SOUNDING TEST RESULT

Proyek : Hotel
 Lokasi : Sedan, Sariharjo, Ngaglik, Sleman
 Test No. : Titik -1
 Ground Level : Tanah Setempat
 Ground Water Level : - m

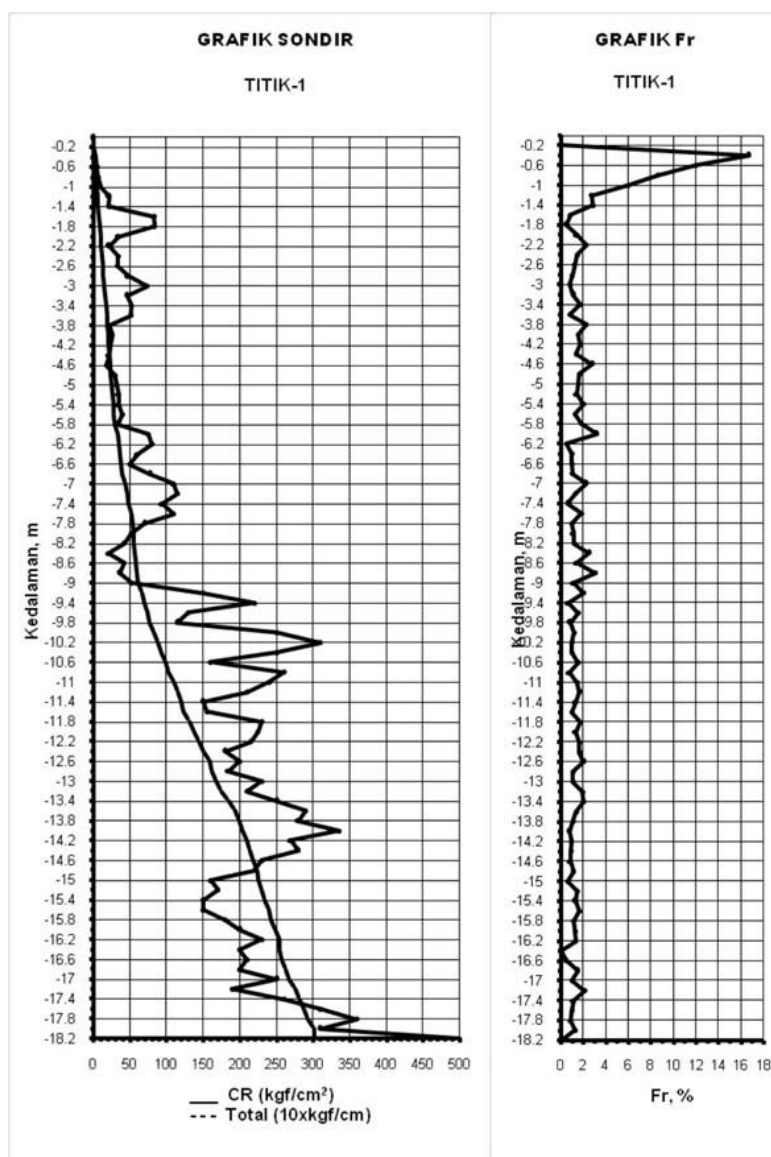
SOUNDING TEST RESULT

Proyek : Hotel
 Lokasi : Sedan, Sariharjo, Ngaglik, Sleman
 Test No. : Titik -1
 Ground Level : Tanah Setempat
 Ground Water Level : - m

<i>Depth</i> (m)	<i>CR</i> kgf/cm ²	<i>CR+LF</i> kgf/cm ²	<i>LF</i> kgf/cm ²	<i>TF</i> kgf/cm	<i>Total</i> kgf/cm
(1)	(2)	(3)	(4)	(5)	(6)
0	0	0	0	0	0
0.2	0	0	0	0	0
0.4	3	8	0.5	10	10
0.6	5	11	0.6	12	22
0.8	7	13	0.6	12	34
1	10	16	0.6	12	46
1.2	22	28	0.6	12	58
1.4	21	27	0.6	12	70
1.6	83	90	0.7	14	84
1.8	84	88	0.4	8	92
2	35	40	0.5	10	102
2.2	22	27	0.5	10	112
2.4	34	39	0.5	10	122
2.6	33	37	0.4	8	130
2.8	48	53	0.5	10	140
3	74	80	0.6	12	152
3.2	46	51	0.5	10	162
3.4	52	61	0.9	18	180
3.6	51	55	0.4	8	188
3.8	22	27	0.5	10	198
4	26	30	0.4	8	206
4.2	23	27	0.4	8	214
4.4	22	25	0.3	6	220
4.6	18	23	0.5	10	230
4.8	30	35	0.5	10	240
5	32	37	0.5	10	250

5.2	35	40	0.5	10	260
5.4	35	42	0.7	14	274
5.6	40	45	0.5	10	284
5.8	33	39	0.6	12	296
6	75	99	2.4	48	344
6.2	80	84	0.4	8	352
6.4	61	67	0.6	12	364
6.6	50	55	0.5	10	374
6.8	77	85	0.8	16	390
7	110	135	2.5	50	440
7.2	115	130	1.5	30	470
7.4	94	100	0.6	12	482
7.6	110	130	2	40	522
7.8	70	77	0.7	14	536
8	52	58	0.6	12	548
8.2	42	47	0.5	10	558
8.4	20	25	0.5	10	568
8.6	42	48	0.6	12	580
8.8	36	47	1.1	22	602
9	52	58	0.6	12	614
9.2	150	180	3	60	674
9.4	220	235	1.5	30	704
9.6	130	150	2	40	744
9.8	115	125	1	20	764
10	250	280	3	60	824
10.2	310	340	3	60	884
10.4	250	275	2.5	50	934
10.6	160	185	2.5	50	984
10.8	260	280	2	40	1024
11	240	275	3.5	70	1094
11.2	210	245	3.5	70	1164
11.4	150	170	2	40	1204
11.6	155	170	1.5	30	1234
11.8	230	270	4	80	1314
12	225	255	3	60	1374
12.2	215	250	3.5	70	1444
12.4	180	210	3	60	1504
12.6	200	240	4	80	1584
12.8	185	205	2	40	1624

13	230	255	2.5	50	1674
13.2	210	250	4	80	1754
13.4	250	300	5	100	1854
13.6	290	330	4	80	1934
13.8	280	310	3	60	1994
14	335	360	2.5	50	2044
14.2	270	295	2.5	50	2094
14.4	280	305	2.5	50	2144
14.6	230	250	2	40	2184
14.8	220	245	2.5	50	2234
15	160	170	1	20	2254
15.2	170	195	2.5	50	2304
15.4	150	170	2	40	2344
15.6	150	175	2.5	50	2394
15.8	180	200	2	40	2434
16	200	225	2.5	50	2484
16.2	230	260	3	60	2544
16.4	200	200	0	0	2544
16.6	210	220	1	20	2564
16.8	200	230	3	60	2624
17	250	275	2.5	50	2674
17.2	190	230	4	80	2754
17.4	260	290	3	60	2814
17.6	310	340	3	60	2874
17.8	360	390	3	60	2934
18	310	350	4	80	3014
18.2	500	500	0	0	3014

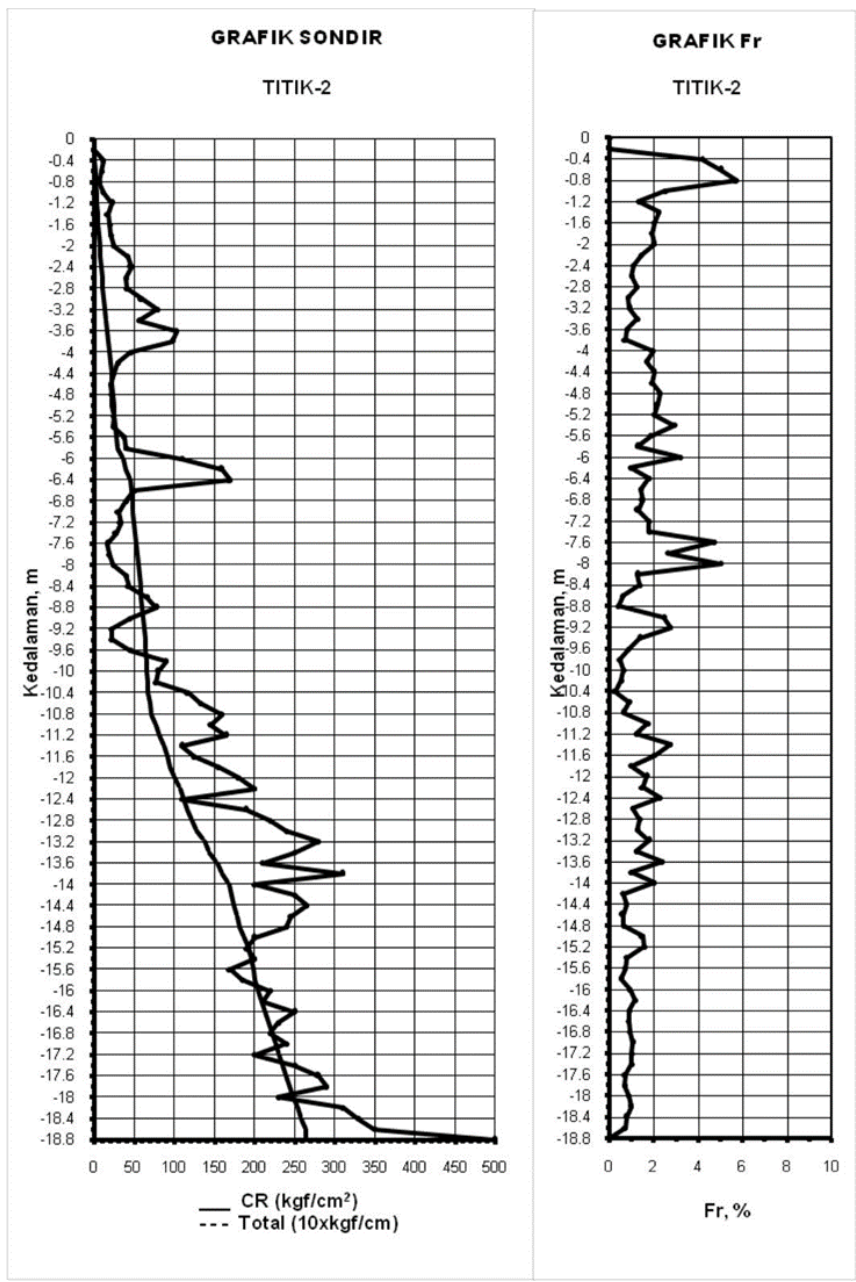
SOUNDING TEST RESULT

Proyek : Hotel
 Lokasi : Sedan, Sariharjo, Ngaglik, Sleman
 Test No. : Titik -2
 Ground Level : Tanah Setempat
 Ground Water Level : - m

<i>Depth</i> (m)	<i>CR</i> kgf/cm ²	<i>CR+LF</i> kgf/cm ²	<i>LF</i> kgf/cm ²	<i>TF</i> kgf/cm	<i>Total</i> kgf/cm
(1)	(2)	(3)	(4)	(5)	(6)
0	0	0	0	0	0
0.2	0	0	0	0	0
0.4	12	17	0.5	10	10
0.6	10	15	0.5	10	20
0.8	7	11	0.4	8	28
1	12	15	0.3	6	34
1.2	23	26	0.3	6	40
1.4	18	22	0.4	8	48
1.6	20	24	0.4	8	56
1.8	21	25	0.4	8	64
2	25	30	0.5	10	74
2.2	42	48	0.6	12	86
2.4	47	52	0.5	10	96
2.6	40	44	0.4	8	104
2.8	41	46	0.5	10	114
3	60	65	0.5	10	124
3.2	79	86	0.7	14	138
3.4	56	63	0.7	14	152
3.6	103	111	0.8	16	168
3.8	98	105	0.7	14	182
4	46	55	0.9	18	200
4.2	30	35	0.5	10	210
4.4	25	30	0.5	10	220
4.6	21	25	0.4	8	228
4.8	22	27	0.5	10	238
5	23	28	0.5	10	248
5.2	25	30	0.5	10	258
5.4	24	31	0.7	14	272

5.6	38	45	0.7	14	286
5.8	40	45	0.5	10	296
6	110	145	3.5	70	366
6.2	160	175	1.5	30	396
6.4	170	200	3	60	456
6.6	50	57	0.7	14	470
6.8	40	46	0.6	12	482
7	31	35	0.4	8	490
7.2	34	40	0.6	12	502
7.4	28	33	0.5	10	512
7.6	17	25	0.8	16	528
7.8	19	24	0.5	10	538
8	24	36	1.2	24	562
8.2	40	45	0.5	10	572
8.4	44	50	0.6	12	584
8.6	66	70	0.4	8	592
8.8	78	81	0.3	6	598
9	45	56	1.1	22	620
9.2	22	28	0.6	12	632
9.4	22	25	0.3	6	638
9.6	46	50	0.4	8	646
9.8	90	94	0.4	8	654
10	80	85	0.5	10	664
10.2	77	81	0.4	8	672
10.4	118	121	0.3	6	678
10.6	133	145	1.2	24	702
10.8	160	170	1	20	722
11	145	170	2.5	50	772
11.2	165	185	2	40	812
11.4	110	140	3	60	872
11.6	125	150	2.5	50	922
11.8	155	170	1.5	30	952
12	180	210	3	60	1012
12.2	200	230	3	60	1072
12.4	110	135	2.5	50	1122
12.6	190	210	2	40	1162
12.8	220	250	3	60	1222
13	240	270	3	60	1282
13.2	280	330	5	100	1382

13.4	250	280	3	60	1442
13.6	210	260	5	100	1542
13.8	310	340	3	60	1602
14	200	240	4	80	1682
14.2	250	265	1.5	30	1712
14.4	265	285	2	40	1752
14.6	245	260	1.5	30	1782
14.8	240	255	1.5	30	1812
15	200	230	3	60	1872
15.2	190	220	3	60	1932
15.4	200	215	1.5	30	1962
15.6	170	182	1.2	24	1986
15.8	185	195	1	20	2006
16	220	240	2	40	2046
16.2	210	234	2.4	48	2094
16.4	250	272	2.2	44	2138
16.6	230	250	2	40	2178
16.8	220	240	2	40	2218
17	240	265	2.5	50	2268
17.2	200	220	2	40	2308
17.4	250	275	2.5	50	2358
17.6	280	300	2	40	2398
17.8	290	310	2	40	2438
18	230	250	2	40	2478
18.2	310	340	3	60	2538
18.4	330	355	2.5	50	2588
18.6	350	375	2.5	50	2638
18.8	500	500	0	0	2638
