LAMPIRAN 1

DATA MEKANIKA TANAH

DATA SABO EKSISTING

Lampiran 3 Data Sabo Eksisting

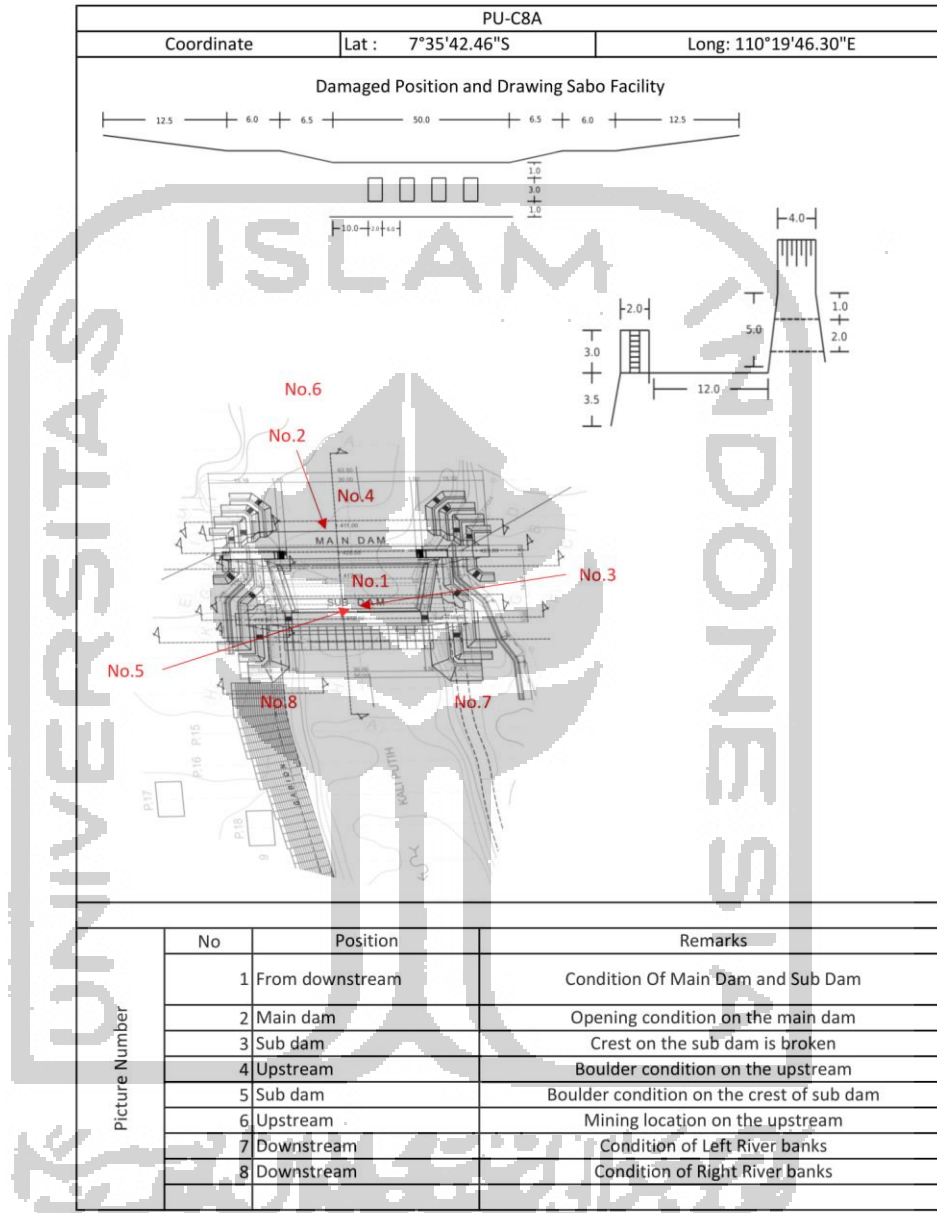
Gambar L3- 2 Data Sabo PU-C8A

Survey Result				
			Survey Date	11/08/2016
Name of Sabo Facility			Surveyor Company	
PU-C8A			Yachiyo Engineering co, LTD	
River Name	Putih	Adress	Srumbung	
Damaged condition of Sabo facility	1. Main dam is abrasion 2. Railing on the main dam is missing 3. Opening on the main dam bunged up/abrasion 4. Sub dam is broken, giant boulder exist on the crest of sub dam			
Condition of both river bank	Left River Bank 1. High \pm 15 m 2. Tilt approx. 70 deg 3. Dyke broken			
	Right River Bank 1. Tilt approx. 80 deg 2. Unstable land			
Condition of sediment storage area	1. Present height of sediment = 2 m 2. Height of pocket = 4.5 m 3. Effective height of Dam = 4,5 m 4. Maximum boulder size at upstream = \pm 2 m 5. Maximum boulder size at downstream = \pm 5 m 6. Traditional mining exist at downstream and upstream			
Condition of

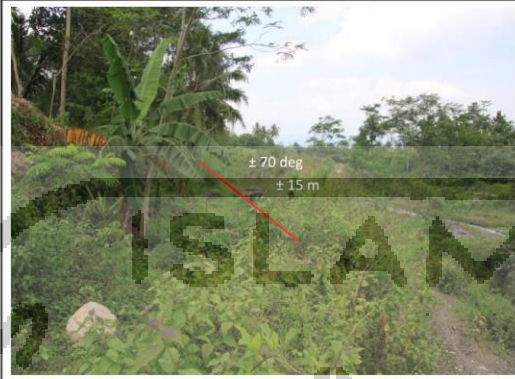
<p>± 70 deg ± 15 m</p>	<p>7. Condition of Left River banks</p> <p>8/11/2016</p>

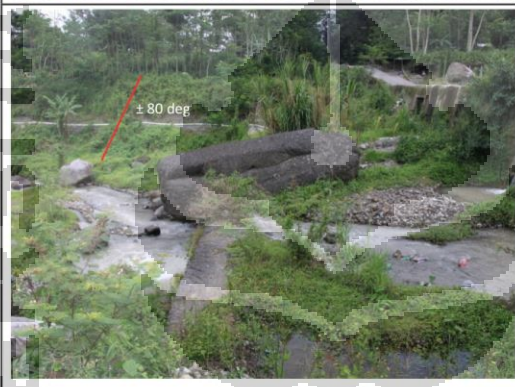
<p>± 80 deg</p>	<p>8. Condition of Right River banks</p> <p>8/11/2016</p>

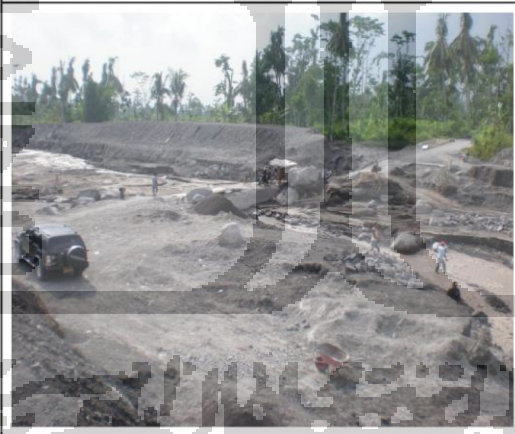
<p>Condition 2011 from upstream</p> <p>21/2/2011</p>

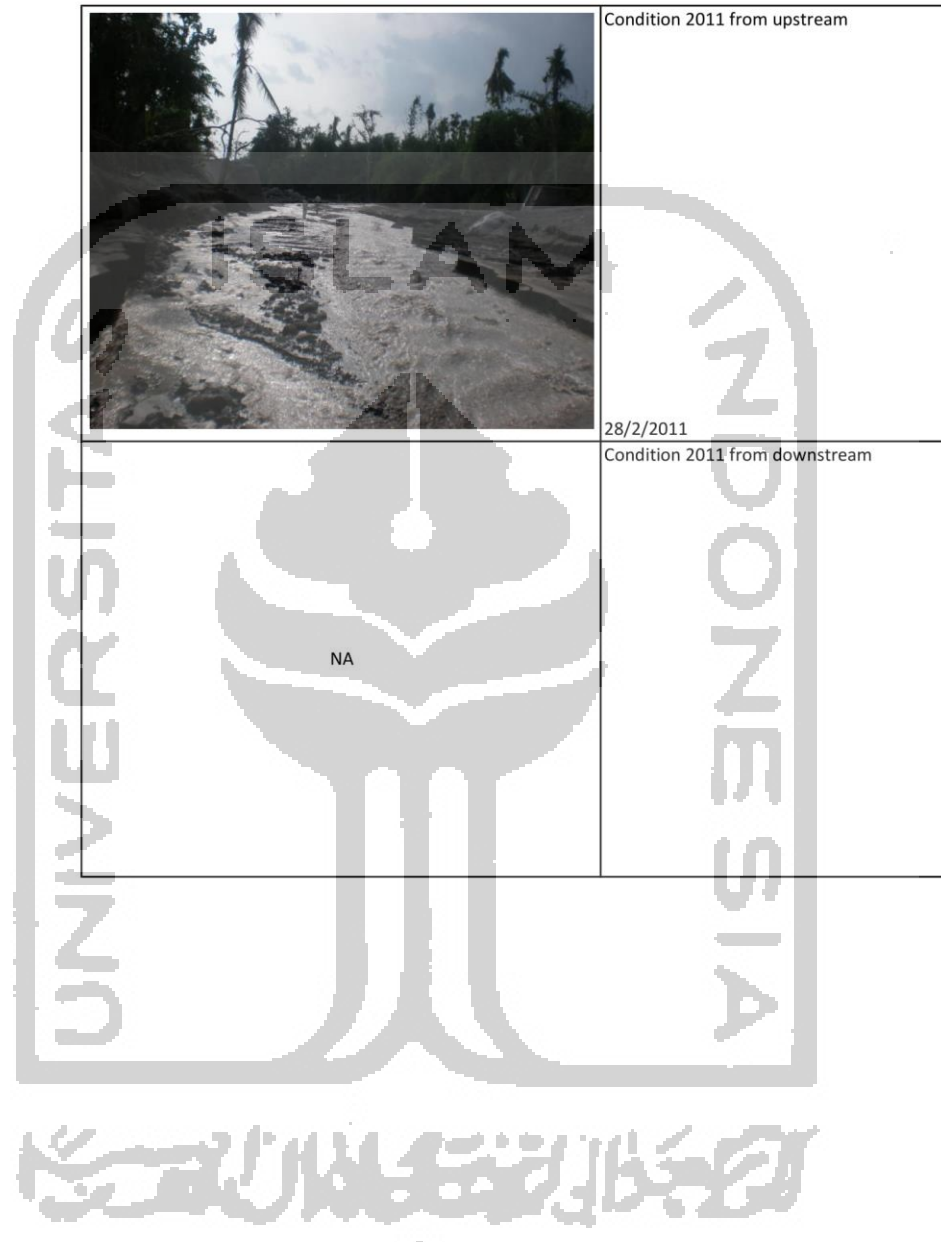
Gambar L3- 11 Data Sabo PU-C8

<p>7. Mining location on the downstream</p> <p>10/11/2016</p>
 	<p>8. Condition of Left River banks</p> <p>10/11/2016</p>
 	<p>9. Condition of Right River banks</p> <p>10/11/2016</p>

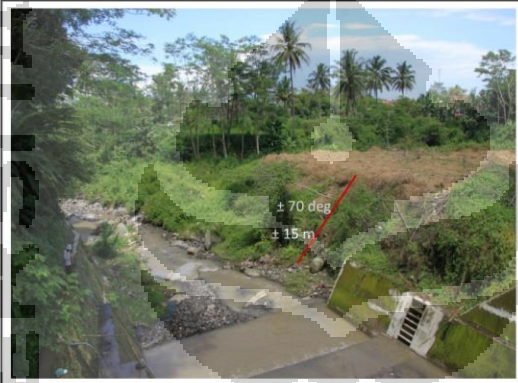
<p>4. Condition of Left River banks</p> <p>10/11/2016</p>

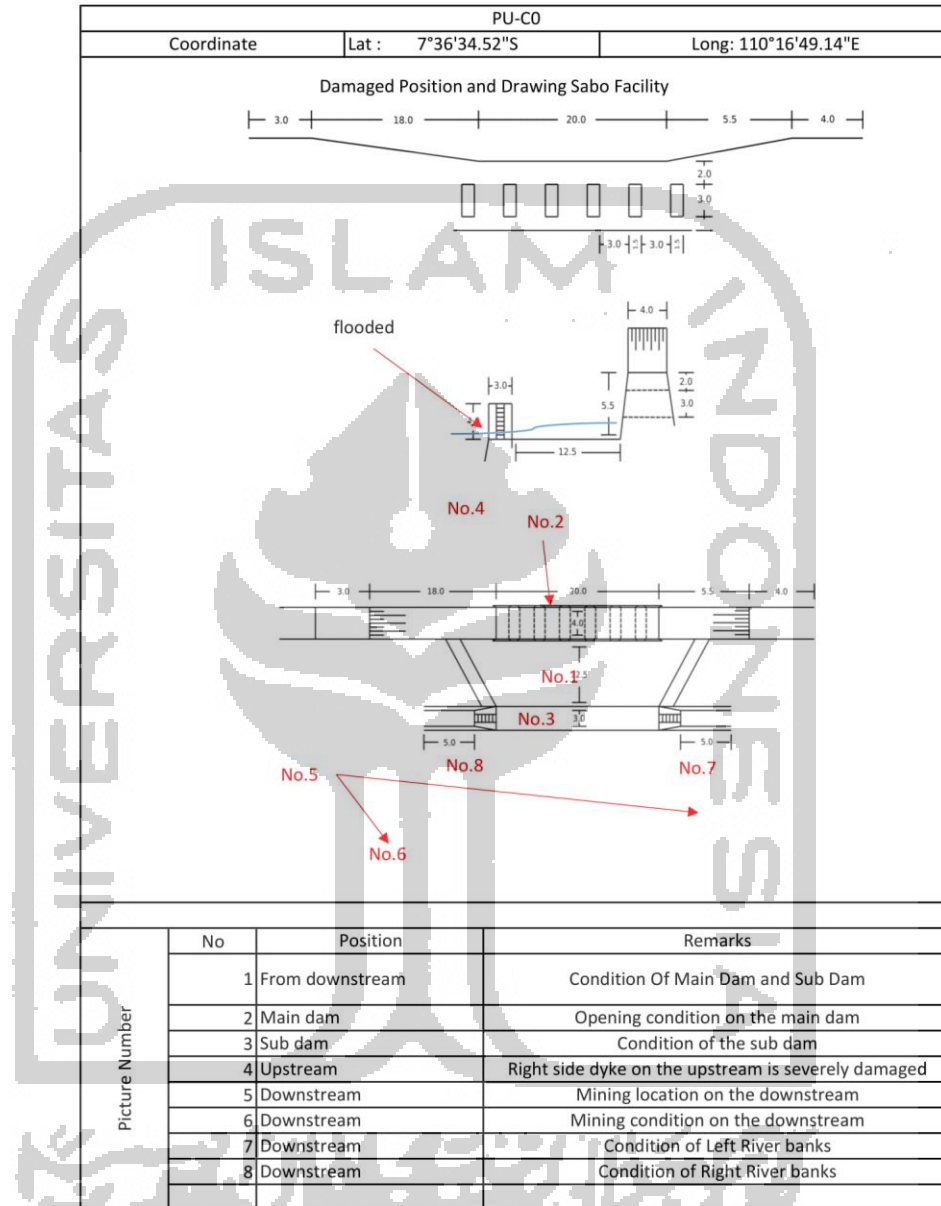
Gambar L3- 17 Data Sabo PU-C0

Survey Result			
		Survey Date	11/10/2016
Name of Sabo Facility		Surveyor Company	
PU-C0		Yachiyo Engineering co, LTD	
River Name	Putih	Adress	Sukowati
Damaged condition of Sabo facility	1. Crest on the main dam is abrasion 2. Opening on the main dam is abrasion 3. Sub dam flooded 4. Right side dyke on the upstream is severely damaged 5. Left side dyke is partially damaged		
Condition of both river bank	Left River Bank 1. High \pm 15 m 2. Tilt approx. 70 deg 3. Dyke exist		
	Right River Bank 1. High \pm 15 m 2. Tilt approx. 90 deg 3. Dyke exist 4. Mining exist by digging		
Condition of sediment storage area	1. Present height of sediment = 2 m 2. Height of pocket = 7.5 m 3. Effective height of Dam = 7.5 m 4. Maximum boulder size = \pm 2 m 5. Mining activity exist until the dyke
