Lampiran 6 Kondisi Awal Model Geometri pada *PLAXIS*

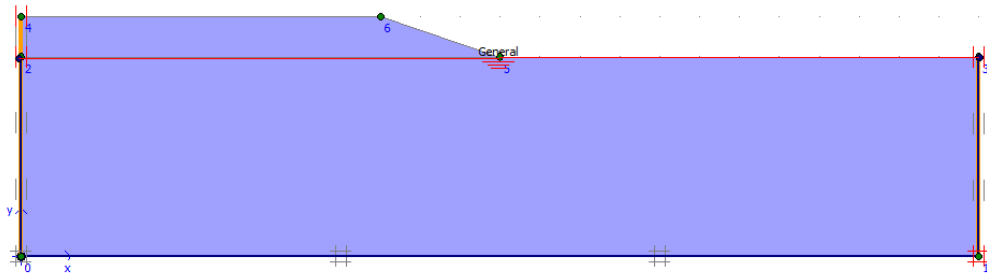
Gambar L-6.1 Kondisi Awal Timbunan 1 m, Tanah Asli 5 m

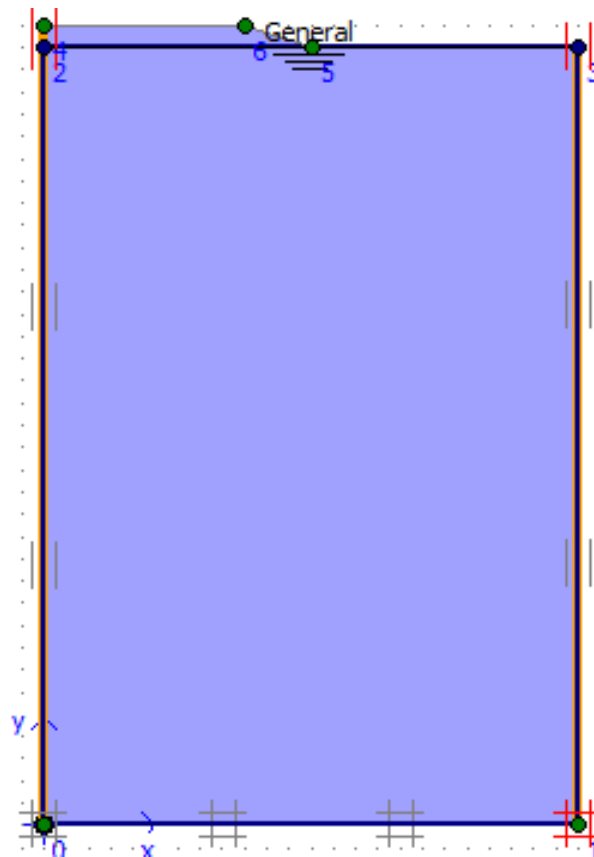
Gambar L-6.2 Kondisi Awal Timbunan 1 m, Tanah Asli 35 m

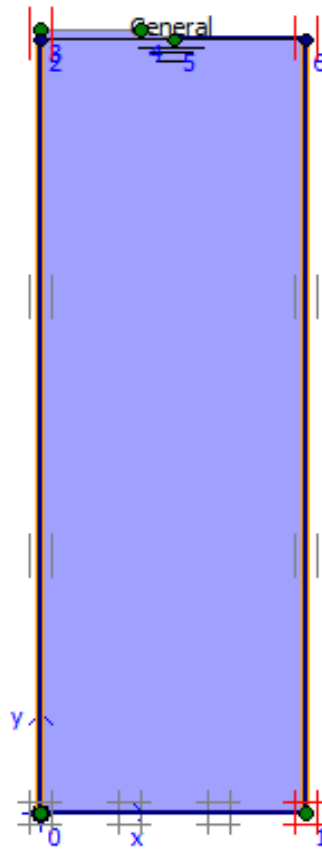
**Gambar L-6.3 Kondisi Awal Timbunan 1 m, Tanah Asli 70 m**

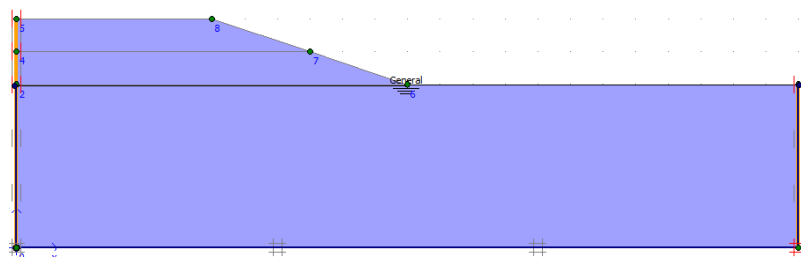
**Gambar L-6.4 Kondisi Awal Timbunan 2 m, Tanah Asli 5 m**

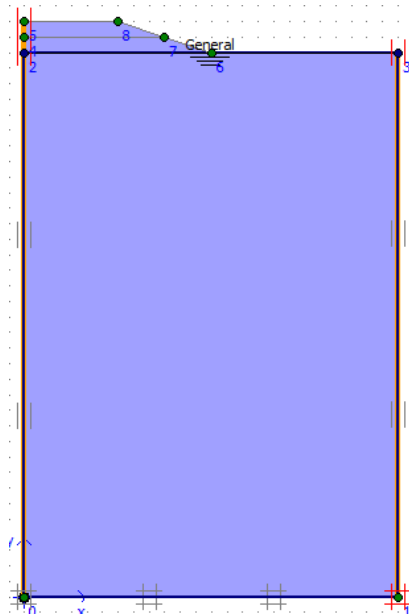
**Gambar L-6.5 Kondisi Awal Timbunan 2 m, Tanah Asli 35 m**

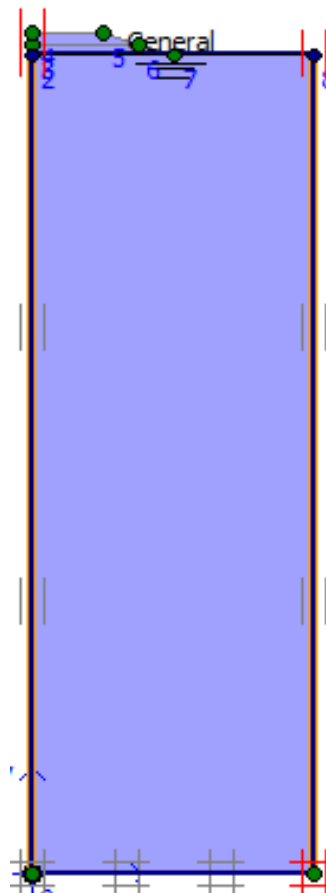
**Gambar L-6.6 Kondisi Awal Timbunan 2 m, Tanah Asli 70 m**

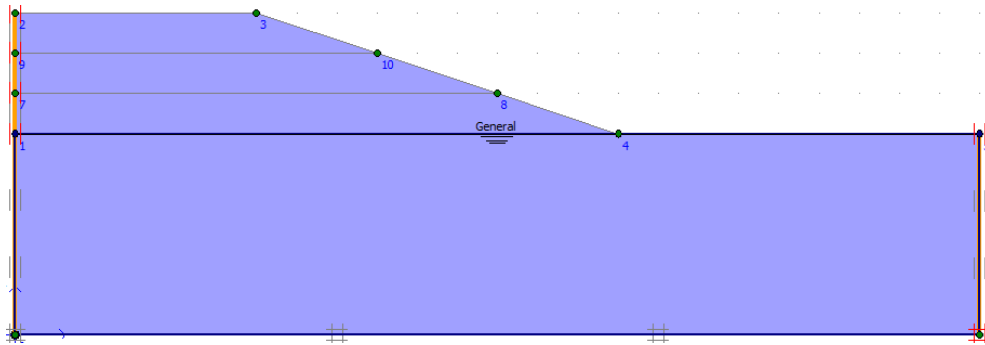
Gambar L-6.7 Kondisi Awal Timbunan 3 m, Tanah Asli 5 m

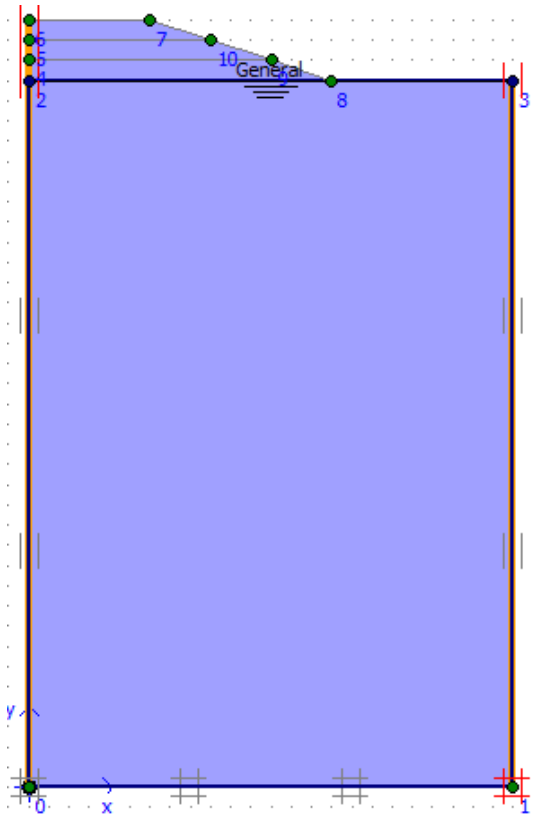
Gambar L-6.8 Kondisi Awal Timbunan 3 m, Tanah Asli 35 m

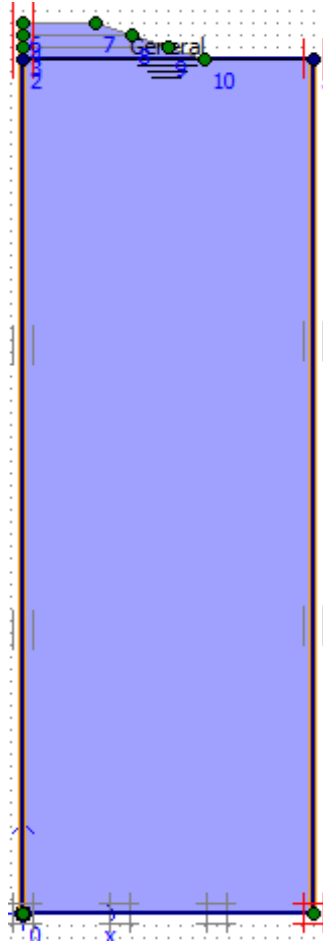
**Gambar L-6.9 Kondisi Awal Timbunan 3 m, Tanah Asli 70 m**

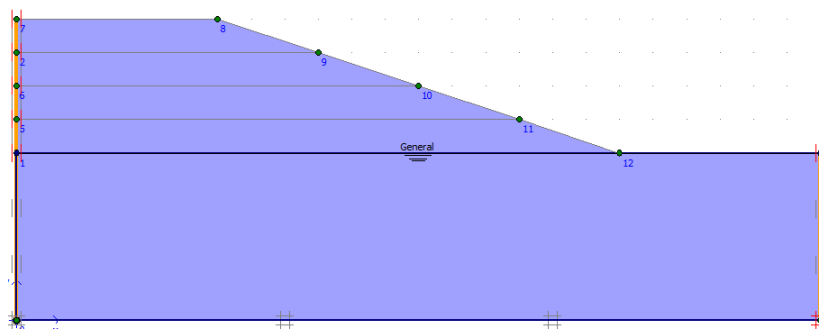
**Gambar L-6.10 Kondisi Awal Timbunan 4 m, Tanah Asli 5 m**

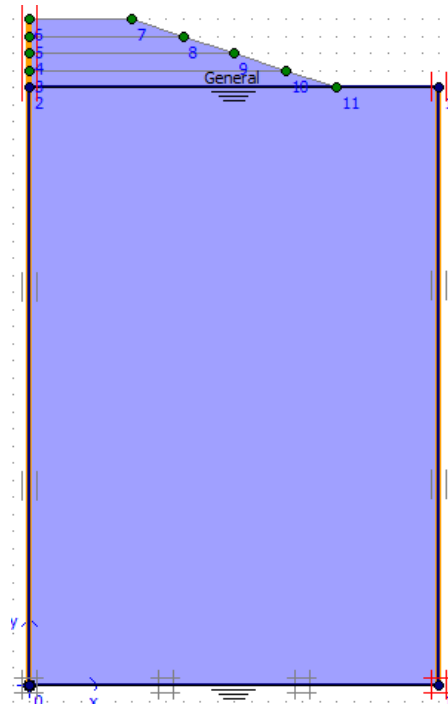
**Gambar L-6.11 Kondisi Awal Timbunan 4 m, Tanah Asli 35 m**
