ASSESSMENT OF FIRE HAZARD SYSTEM AND EVACUATION ROUTE QUALITY: COSAN CAFE AND DRAGON HOTPOT BUILDING

Chairunisa Dwitya Vanti¹, Noor Cholis Idham², dan Mahadevi Effia Arkan³

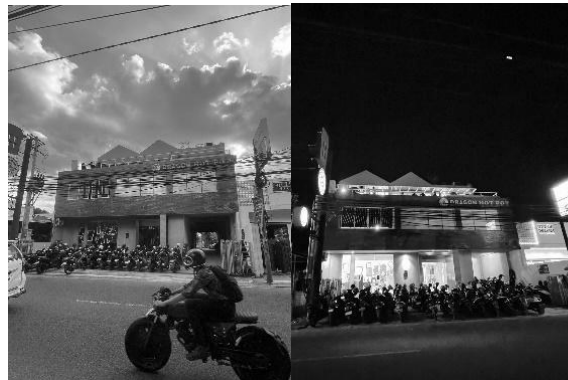
Image 1 Front building facade

The exterior of the Cosan Cafe and Dragon Hotpot building is covered in a combination of concrete and red bricks. With a minimalist box-shaped design, it is clear that the building

has a large opening design with a ratio of 6:10 of the wall area. Massive use of glass, brick and concrete materials will have a major impact on the strength of the building against fire hazards.

All three materials are part of non-combustible materials that support the building structure to withstand fire hazards. The application of material location is also very important in the Cosan Cafe and Dragon Hotpot buildings. The reason is that all boundaries between the inside and outside of the building use tempered glass. Lightweight tempered glass is implemented as doors and windows so that evacuation needs are very easy to do. Concrete materials are applied as the main columns to support the strength of the building structure so that it is not vulnerable to collapse and fire.

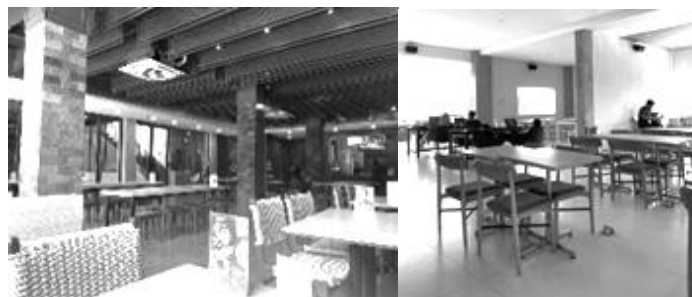
Image 2 Interior visualization (a) Dragon Hotpot & (b) Cosan Cafe

This building is famous for its beautiful interior design with traditional Chinese nuances in the Dragon Hotpot section and futuristic in the Cosan Cafe section. The majority of materials that are often implemented are wood as an interior form of tables and chairs. This combustible material triggers the fastest spread of fire in fire hazards. The dense interior arrangement also supports a very dangerous fire outbreaks distribution medium (CFPA-E, 2023). On the other hand, the interior wall design at Dragon Hotpot restaurant implements wood ornaments as the main aesthetic value. The implementation of wood on brick walls is a contradiction to the strength of the building in the face of fire.

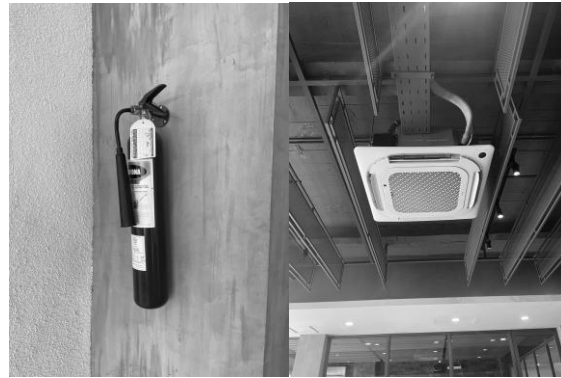
Image 3 Fire safety tools APAR (a) and the implementation
 Source : Writer, 2024

This low-rise building has a fire hazard system that is considered insufficient to meet existing standards. The assessment identifies the active protection system in the building is considered quite low in the provision of facilities. Such as smoke detectors, smoke control devices and smoke exhausts have a small quantity per building floor. The placement of fire hazard equipment is too far to be reached on the side of certain rooms. Besides, that fire hazard equipment also has different categories or types and some of the tools were already expired.

The placement of fire hazard equipment aligns with the direction of hazard warning and evacuation. For example, the extinguisher is placed close to the emergency stairs and the exhaust system on each room’s ceiling. When the danger manual warning and evacuation process starts, users can reach the tools quickly and concisely while evacuating themselves. This action is in accordance with research conducted by Bryan (1982) where the fire management system will support the evacuation process.

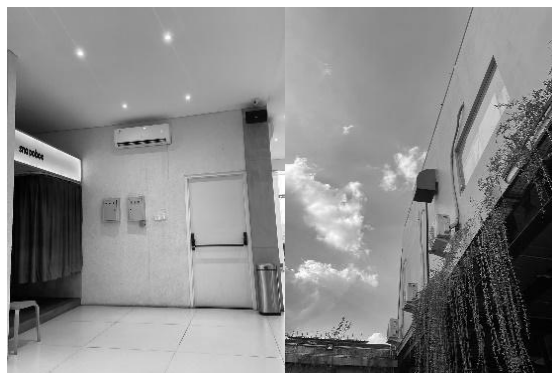
Image 5 Electrical fuses at the storey 3 and exhaust at storey 2
Source : Writer, 2024

The building has a smoke exhaust duct that leads to the west of the building, but its exhaust capacity is still insufficient with its size of 15 inches. In addition, the lift transport system in this building does not fully meet fire hazard standards. The lift has instructions and hazard warnings in addition to the infrastructure is equipped with metal shaft parts that are resistant to fire. The assessment of these two aspects of the building can be categorized as 'Sufficient' with a condition score of 1,344.

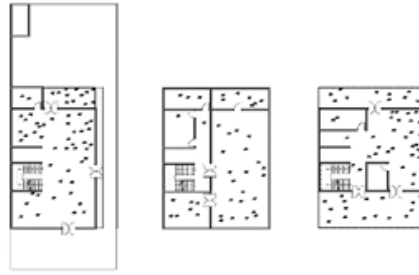
Image 6 Density and distribution of building
Source : Writer, 2024 on all these floors

The evacuation quality assessment of the Cosan Cafe and Dragon Hotpot building has several evaluation aspects. The main influence of evacuation quality comes from the number, habits and preparedness of the users in dealing with fire hazards. The number of building users is formed by the number of visitors and workers at the same time. The average user density of the building is 180 people spread over 50-70 people per floor.

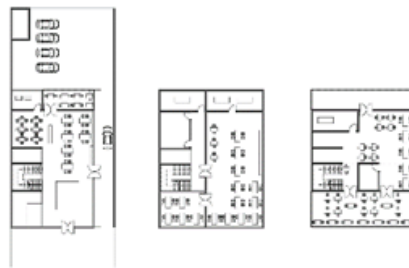
Image 7 Interior layout at all three floors
Source : Writer, 2024

In addition to the density of users, the number and interior arrangement of tables and chairs are also very influential for the quality of evacuation movement. The large number of tables and chairs designated on the 1st and 3rd floors is a challenge and obstacle for users to transport from one place to another. This situation will encourage a longer time in evacuation and reduce the quality of evacuation in wayfinding. In accordance with research conducted by Sari, P. (2022) the improper arrangement of goods will affect the ease of finding evacuation routes. This problem is the assessment in this research.

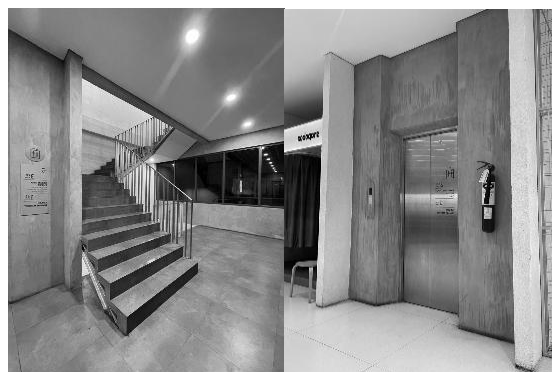
Image 8 Building vertical transportation system
Source : Writer, 2024

The Cosan cafe and Dragon Hotpot building has a vertical transport system in the form of stairs and elevators. These two transportations have adjacent placement positions and are located on the south side of the building. Under the circumstances, when a fire disaster occurs the direction of evacuation will be centered on the 1,5 meter width stairs. However, this will create interference between users. This interference will affect the quality of evacuation based on inadequate evacuation route design.

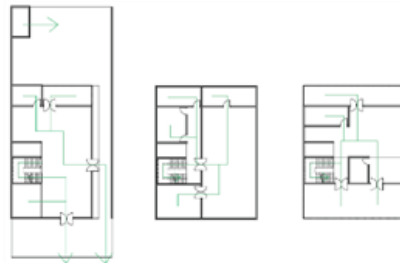
Image 9 Evacuation route at all three floors
Source : Writer, 2024

Based on the evacuation route drawn on the 3 floors of the Cosan Cafe and Dragon Hotpot building, there are 2 main exits located on the north and east sides of the building. The north exit has a longer distance to the hazard-free field area. While the east door is closer to the open area in the form of a motorway. Both of these create the potential for a closer selection of evacuation routes. Unfortunately, this also has the potential to create collisions that occur due to the accumulation of users at one time and place. This potential problem requires further analysis using Pathfinder software.

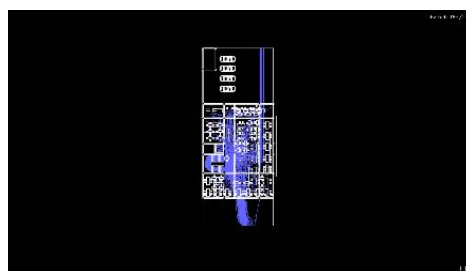
Image 10 Plan of flow simulation shows congestion
Source : Writer, 2024

The simulation with this first scenario shows the density of the flow of visitors. In the figure, it is clear that the congestion and interference of users' directions are centered on the stairs. Besides that, there are two directions of evacuation exit paths that lead west and east. The west route has a greater distance compared to the east route, hence the higher density of use of the east evacuation route.

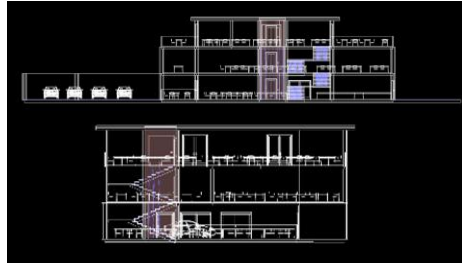
Image 11 Section of flow simulation shows density
Source : Writer, 2024

In addition, another factor that affects the buildup of emergency staircase use is the condition of elevator (lift) access which is considered to take a lot of time and also makes users have to wait a while. The speed of travel and waiting for elevators (lifts) in this building is 3 minutes, with a capacity of 10 people in it. This is what makes users prefer to use emergency access rather than elevators. Overall, the simulation with scenario 1 took 161 seconds to evacuate. With the possibility of additional delay due to the barrier factor of 180 seconds. Therefore, the total evacuation time is 341 seconds.

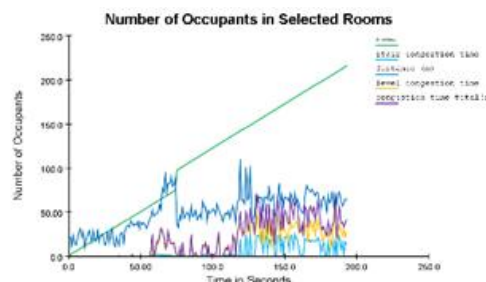
Image 13 Bottleneck test result for user in space
Source : Writer, 2024

Based on the graph above, the highest and most frequent congestion is found in the evacuation lane distance. In other words, the evacuation route creates a large queue so that congestion causes congestion in the evacuation route. The highest congestion occurs at 123 seconds, where users accumulate on the first floor in queuing for the building exit, which is in line with Figure 11. In addition, the second large spike occurs at 60 seconds where users choose 2 evacuation accesses, one of which is the elevator. At 160 seconds, the congestion was at an average level which illustrates that the evacuation routes were filled with users evenly without any major obstacles.

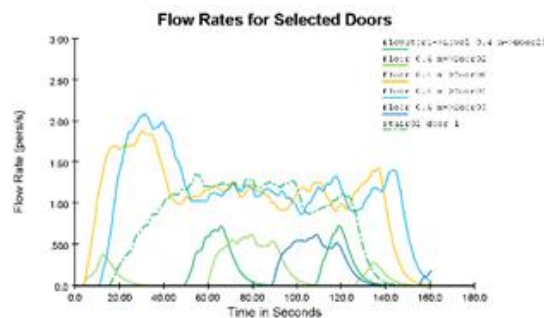
Image 14 Evacuation route selection test result

Based on the figure, users are more inclined to use the eastbound evacuation route (yellow & light blue) compared to the north-west evacuation route (light green & dark blue). The selection of vertical transport access shows that users prefer to use stairs as an evacuation route rather than elevators. It can be concluded that closer evacuation routes and fast transport access are the main choices of users in this simulation. However, at the same time, this scenario has several drawbacks such as congestion due to queues, delays in transport waiting times, inefficient evacuation and inefficient use of both evacuation routes.
