Lampiran 2 : Grafik Nilai Pengurang (*Deduct Value*) (1 dari 5)

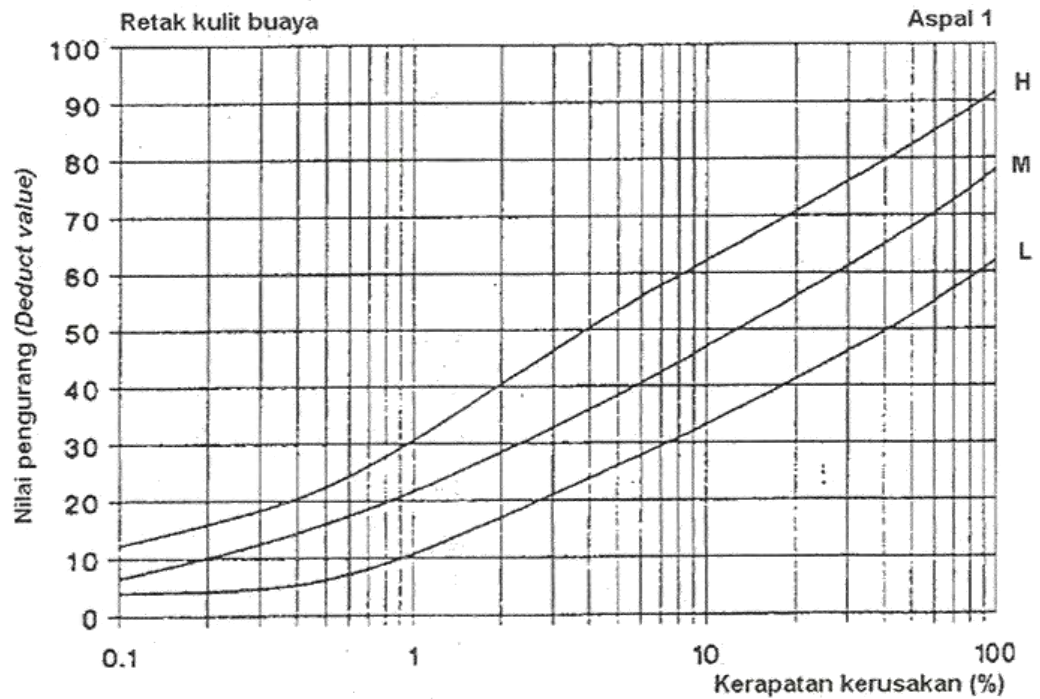
Retak Kulit Buaya (*Alligator Crack*)

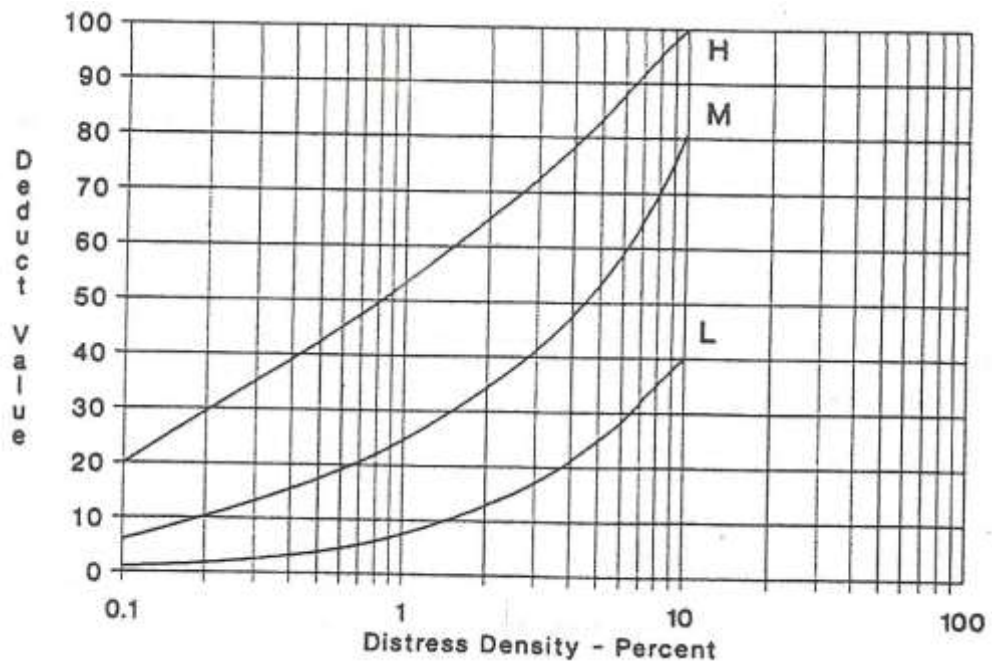
Benjol dan Turun (*Bump And Sags*)

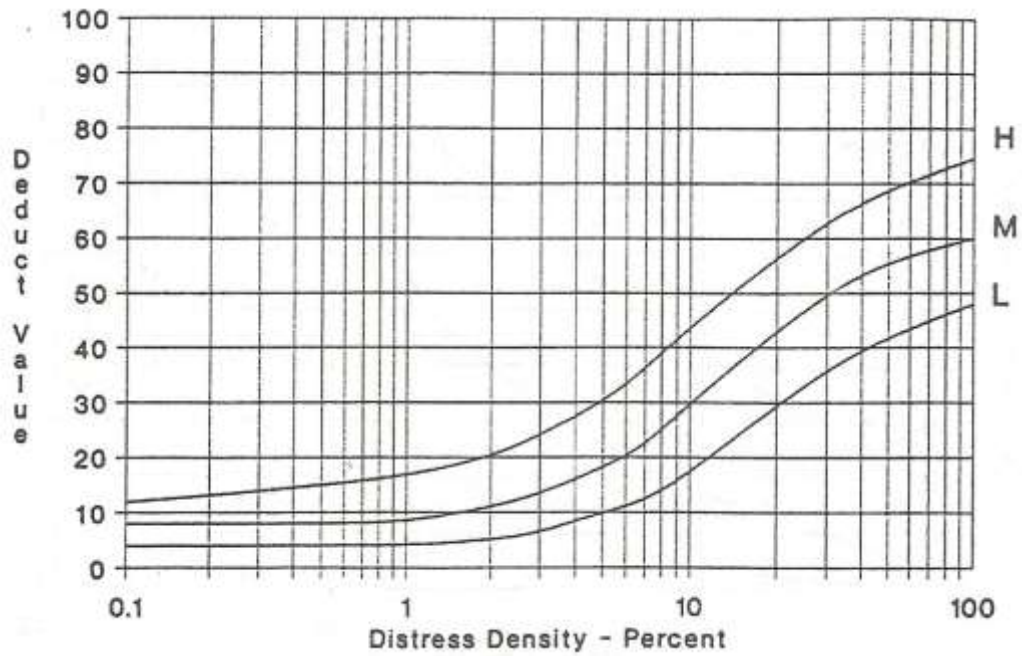
Amblas (*Grade Depression*)

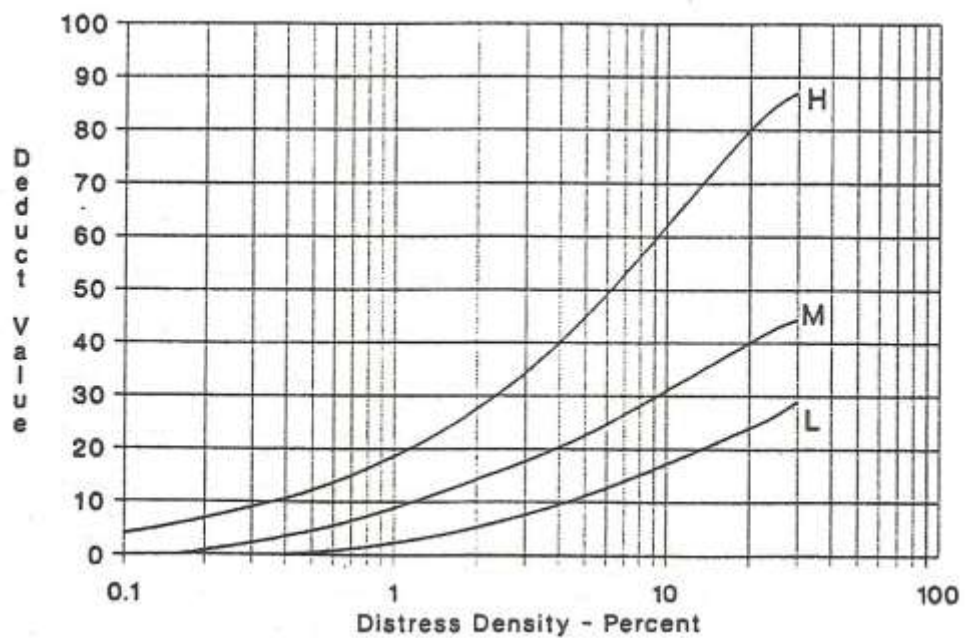
Memanjang (*Longitudinal Cracks*)

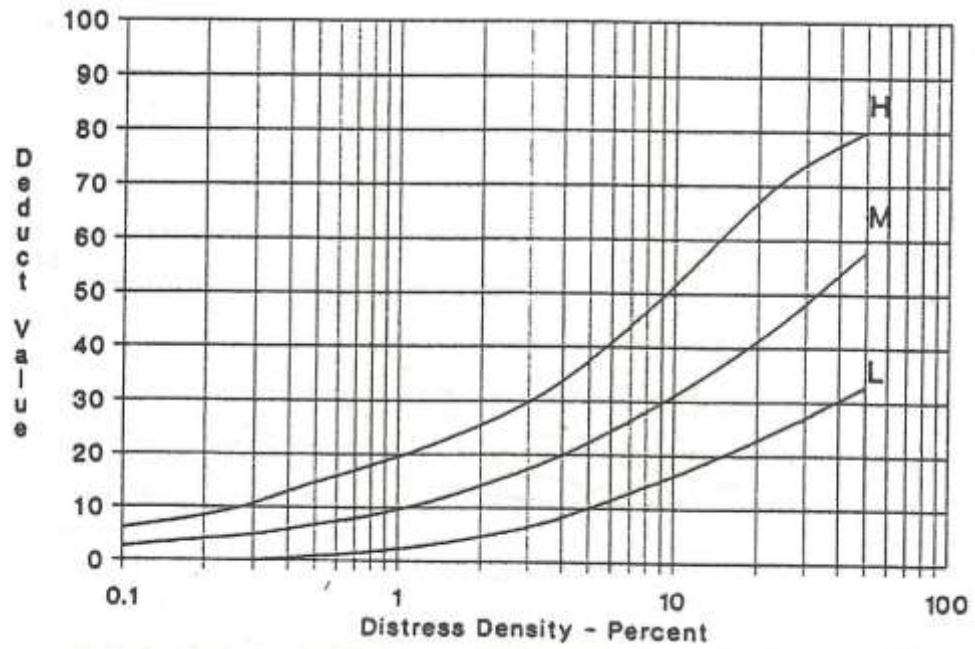
Tambalan(*Patching*)

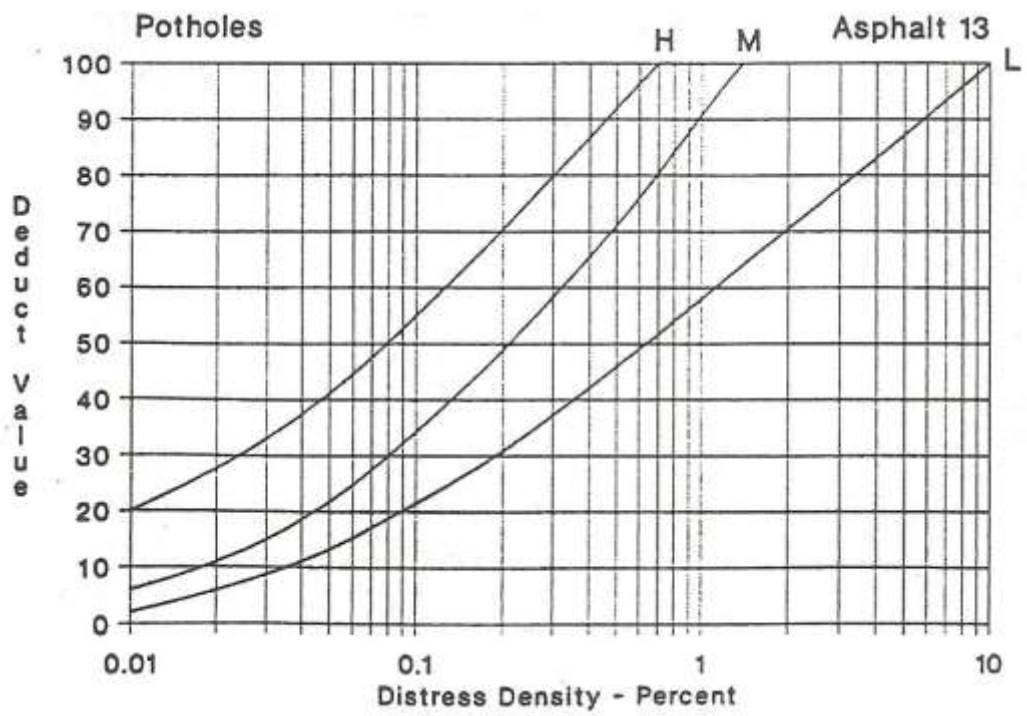
Lubang(*Potholes*)

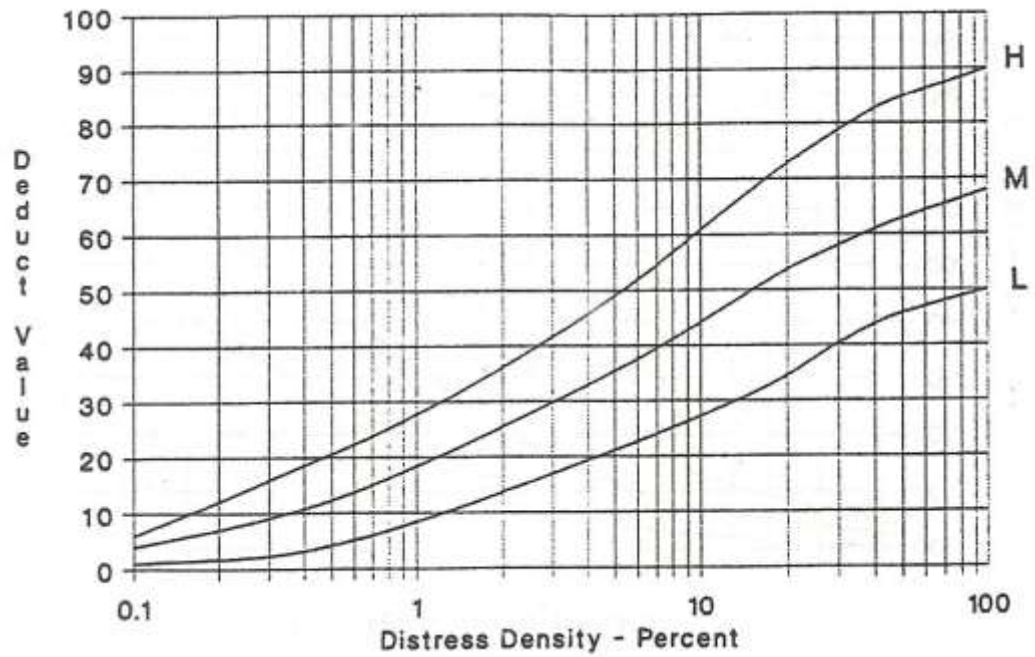
Alur (*Ruts*)

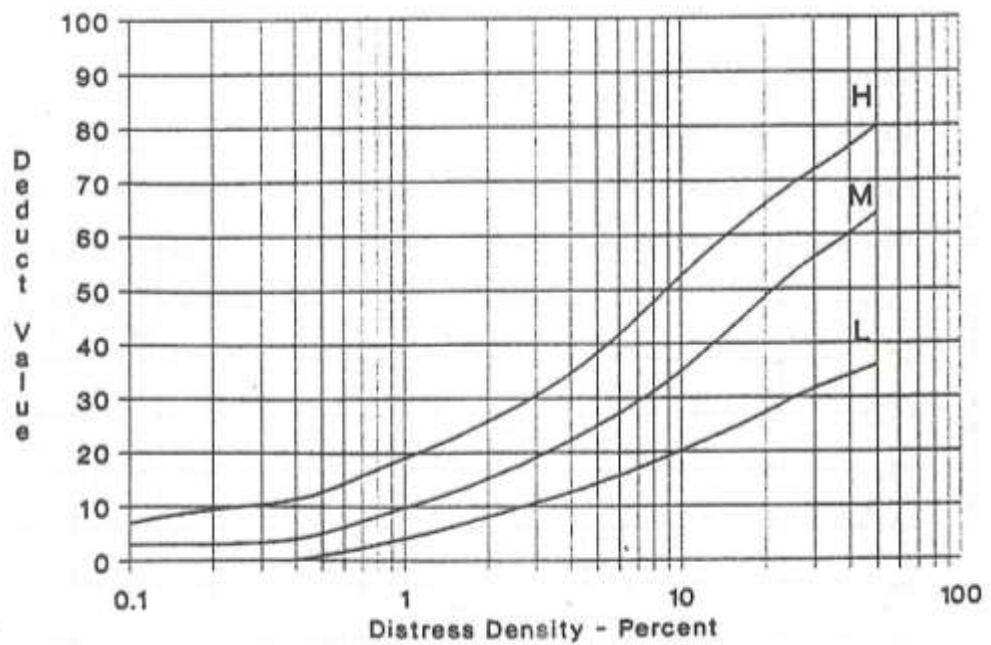
Sungkur (*Shoving*)

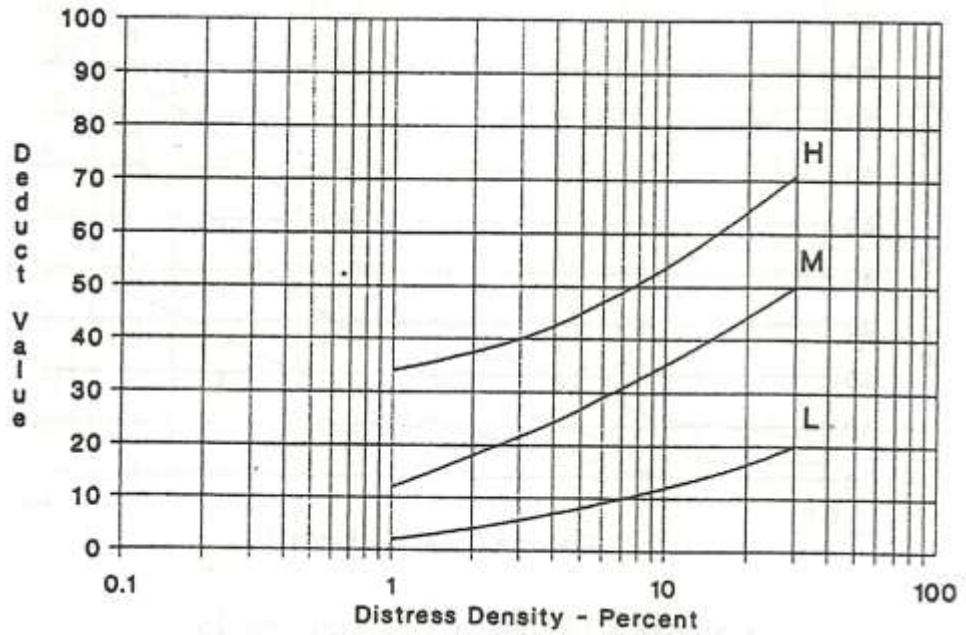
Pengembangan (*Swell*)

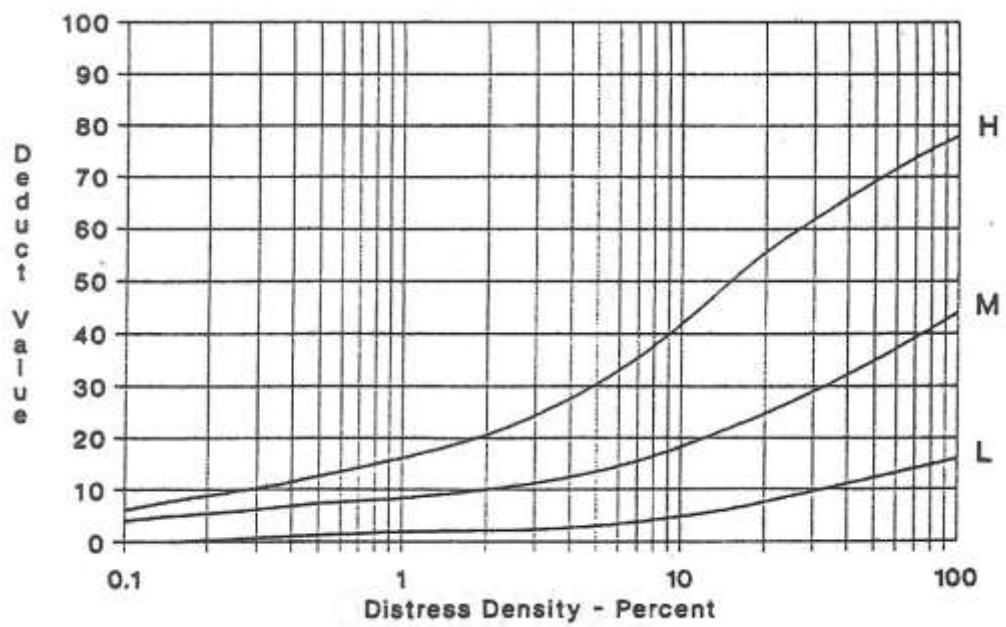
Pelepasan Butiran (*Raveling*)

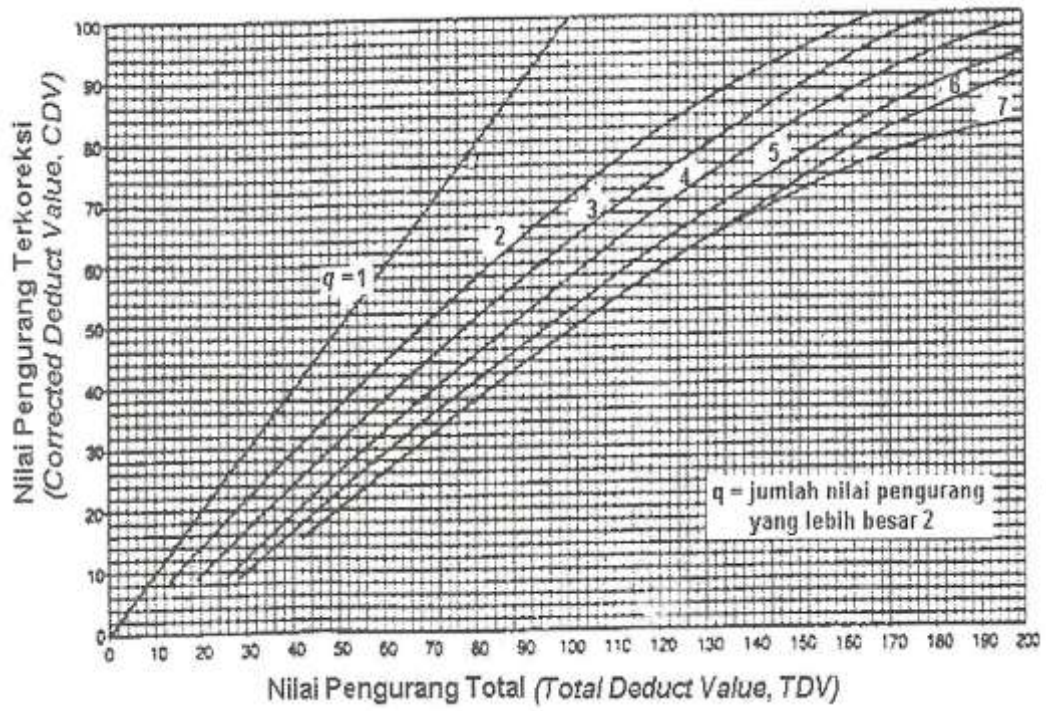
Grafik *Corrected Deduct Value (CDV)*
