Lampiran 1 Penampang Melintang Lokasi Penelitian

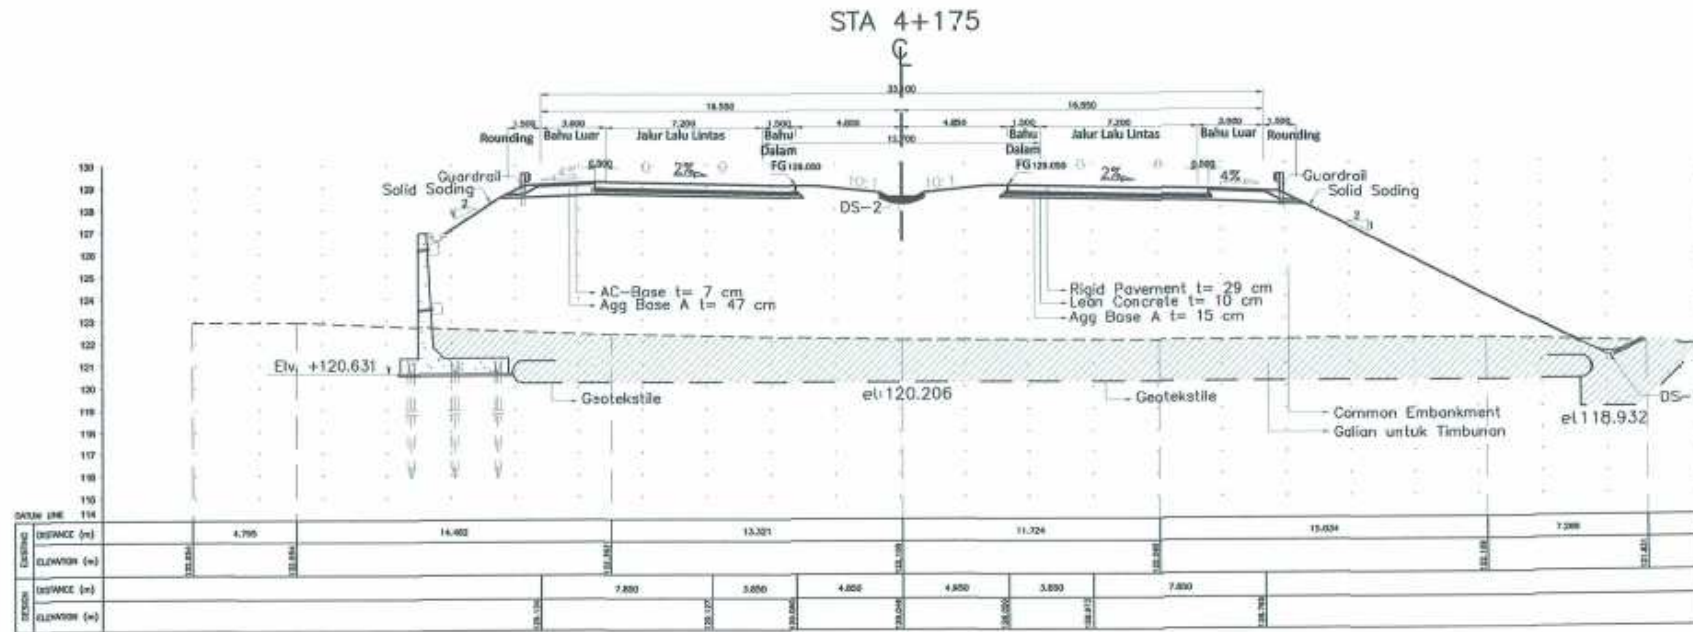
Gambar L-1.1 Penampang Melintang Badan Jalan Tol Solo-Kertosono Sta. 4 + 175
