Lampiran 2. Data Cone Penetration Test (CPT)

NSE <small>Nur Straits Engineering</small>		Cone Penetration Test (CPT) CPT Log					
Project	DED Bandara Kulon Progo		Date	: 6/13/2017			
Location	Desa Glagah Kec. Temon - Kulon Progo		Operator	: DEDE M			
CPT No.	1		Checked by	: Hasan Tri Atmojo			
Coordinate	E 0397590 N 9125502		Field Condition	: Fair Weather			
Elevation			Page	: 1 of 1			
Depth	R1	R2	(R2-R1)	qc	LF	TF	Rf
m	Kg/cm ²	Kg/cm ²	Kg/cm ²	Kg/cm ²	Kg/cm ²	Kg/cm	%

CONE PENETRATION TEST ASTM D3441

RTT Sisi Udara Bandara New Yogyakarta International Airport

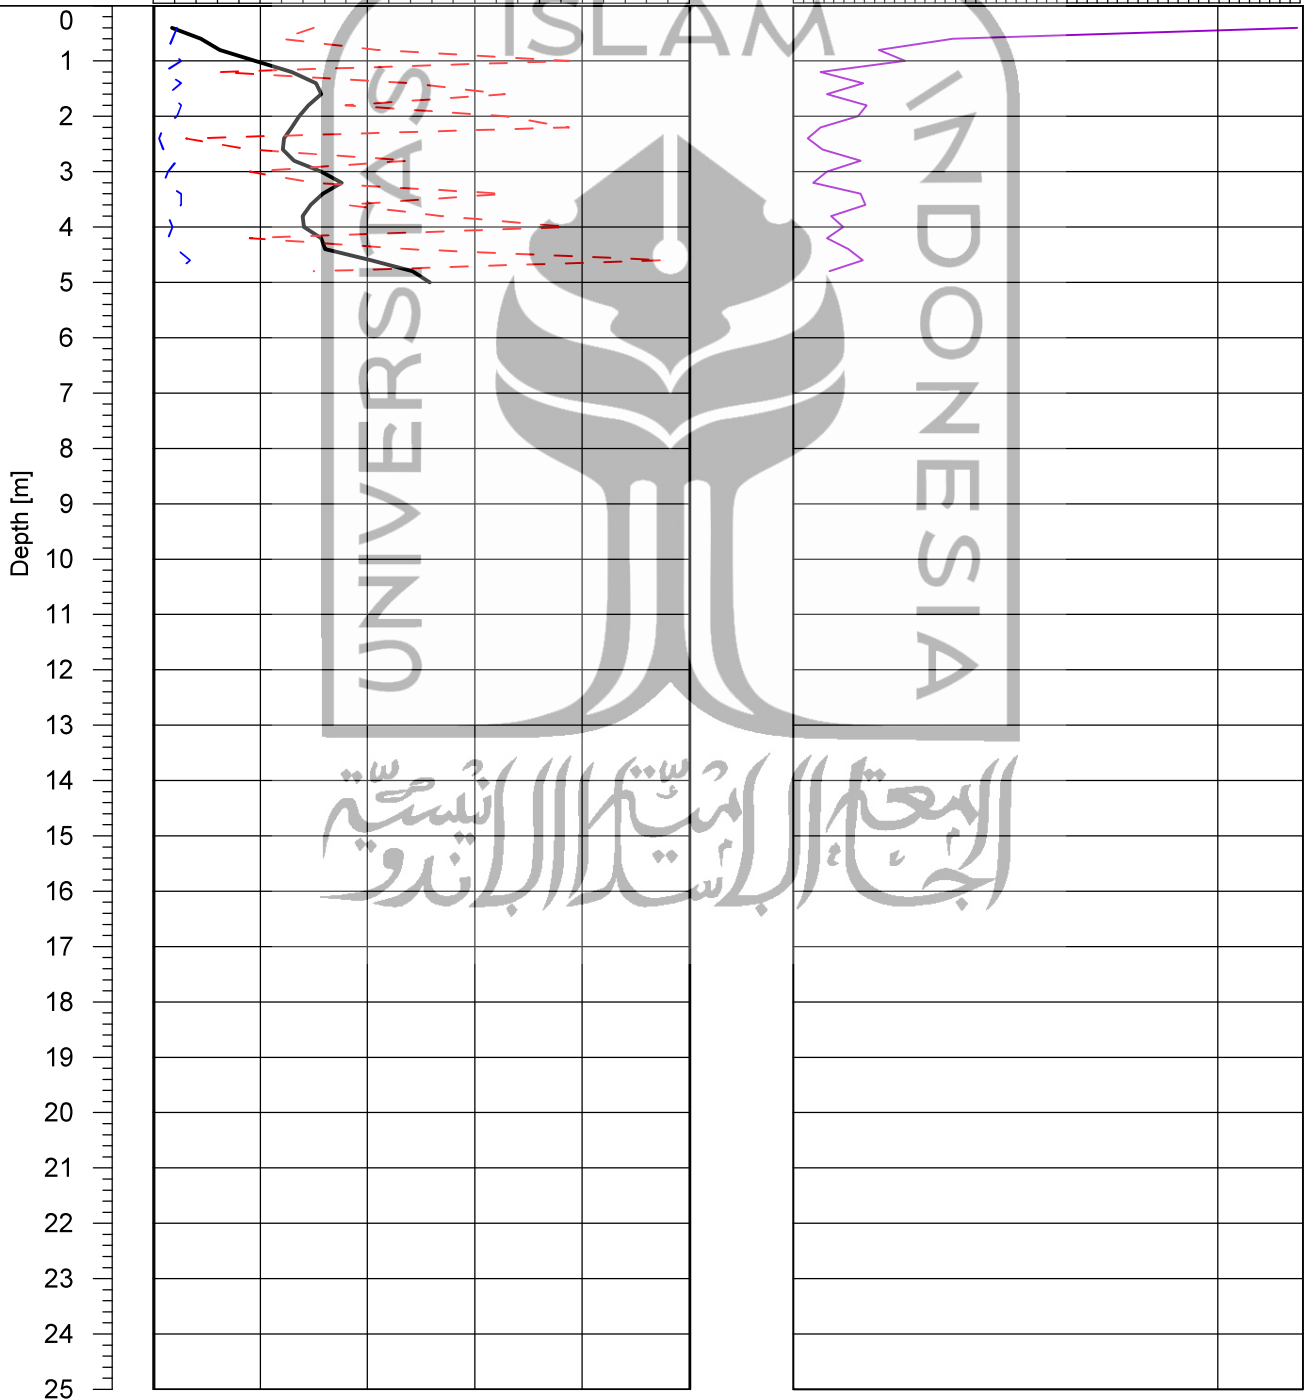
CPT No :
CPT - 01

Client : PT. Angkasa Pura I
Location : Desa Glagah Kec. Temon - Kulonprogo
Easting : 397590 m
Northing : 9125502 m
Elevation :

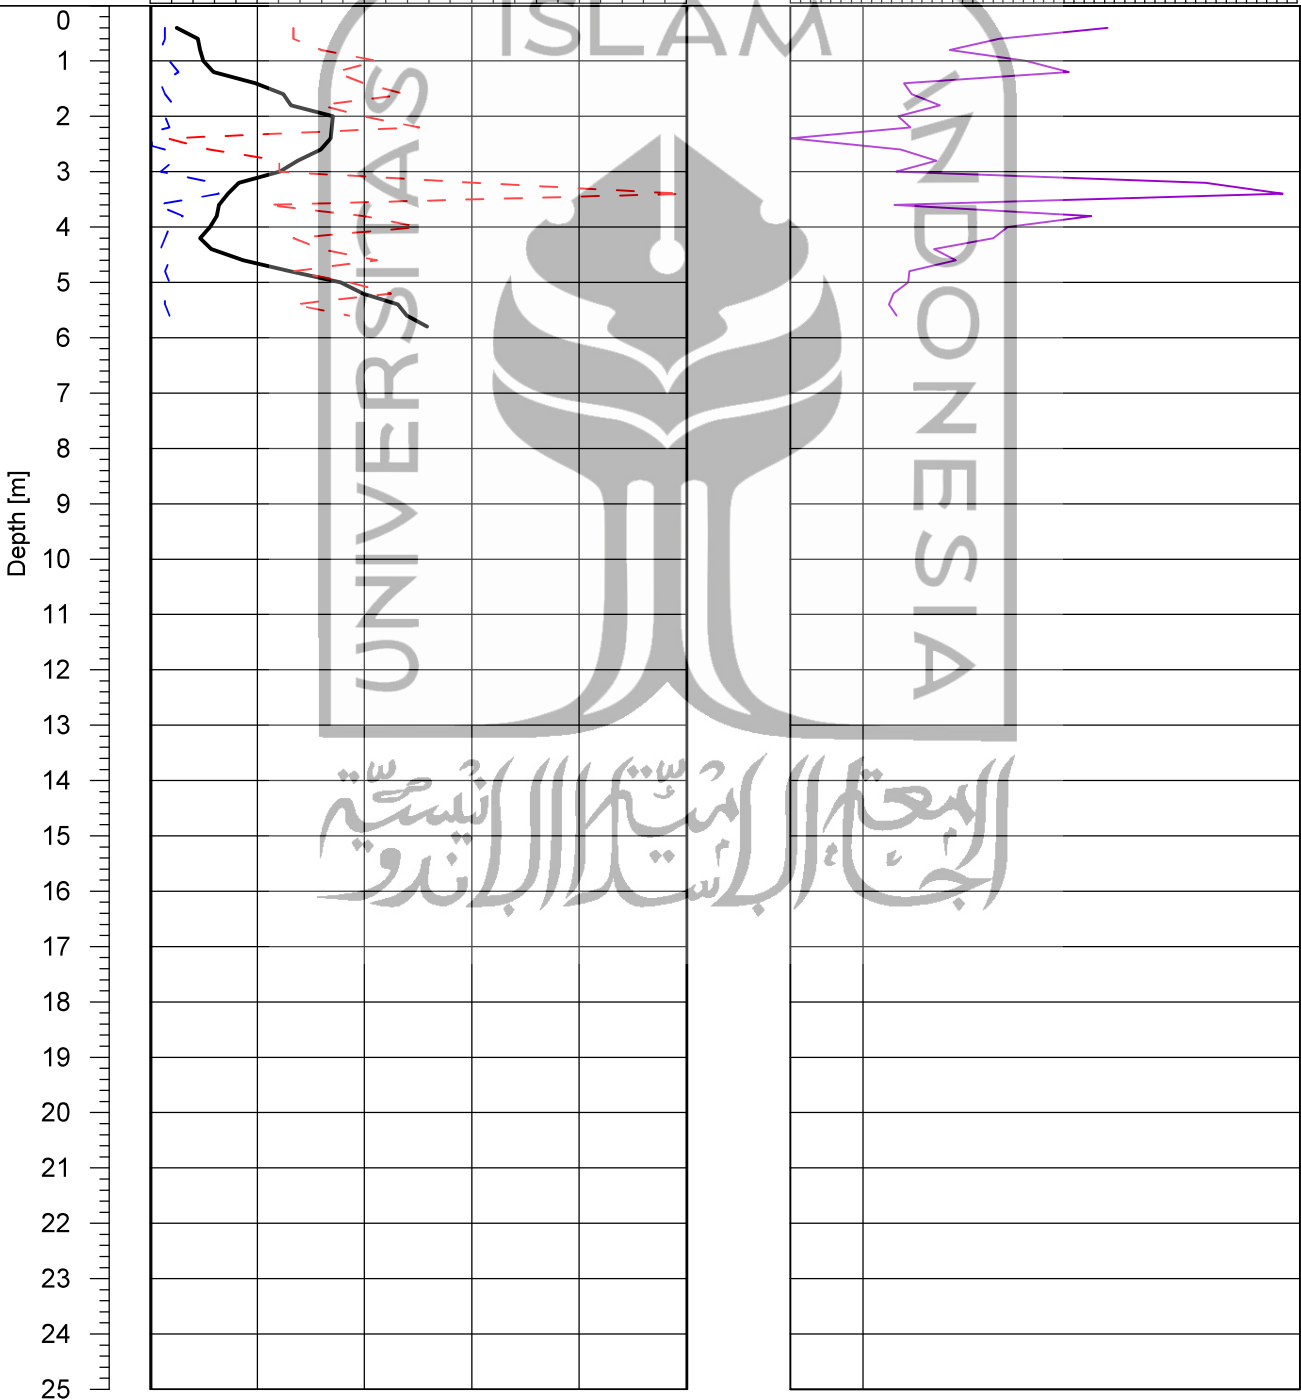
CPT No :
CPT - 02

CONE PENETRATION TEST ASTM D3441

Client : PT. Angkasa Pura I
Location : Desa Glagah Kec. Temon - Kulonprogo
Easting : 397479 m
Northing : 9125507 m
Elevation :

— : Friction Ratio, Rf [%]
— : Cone Friction, qc [kg/cm²]
- - - : Friction, LF [kg/cm²]
- - - : Total Friction, TF [kg/cm]

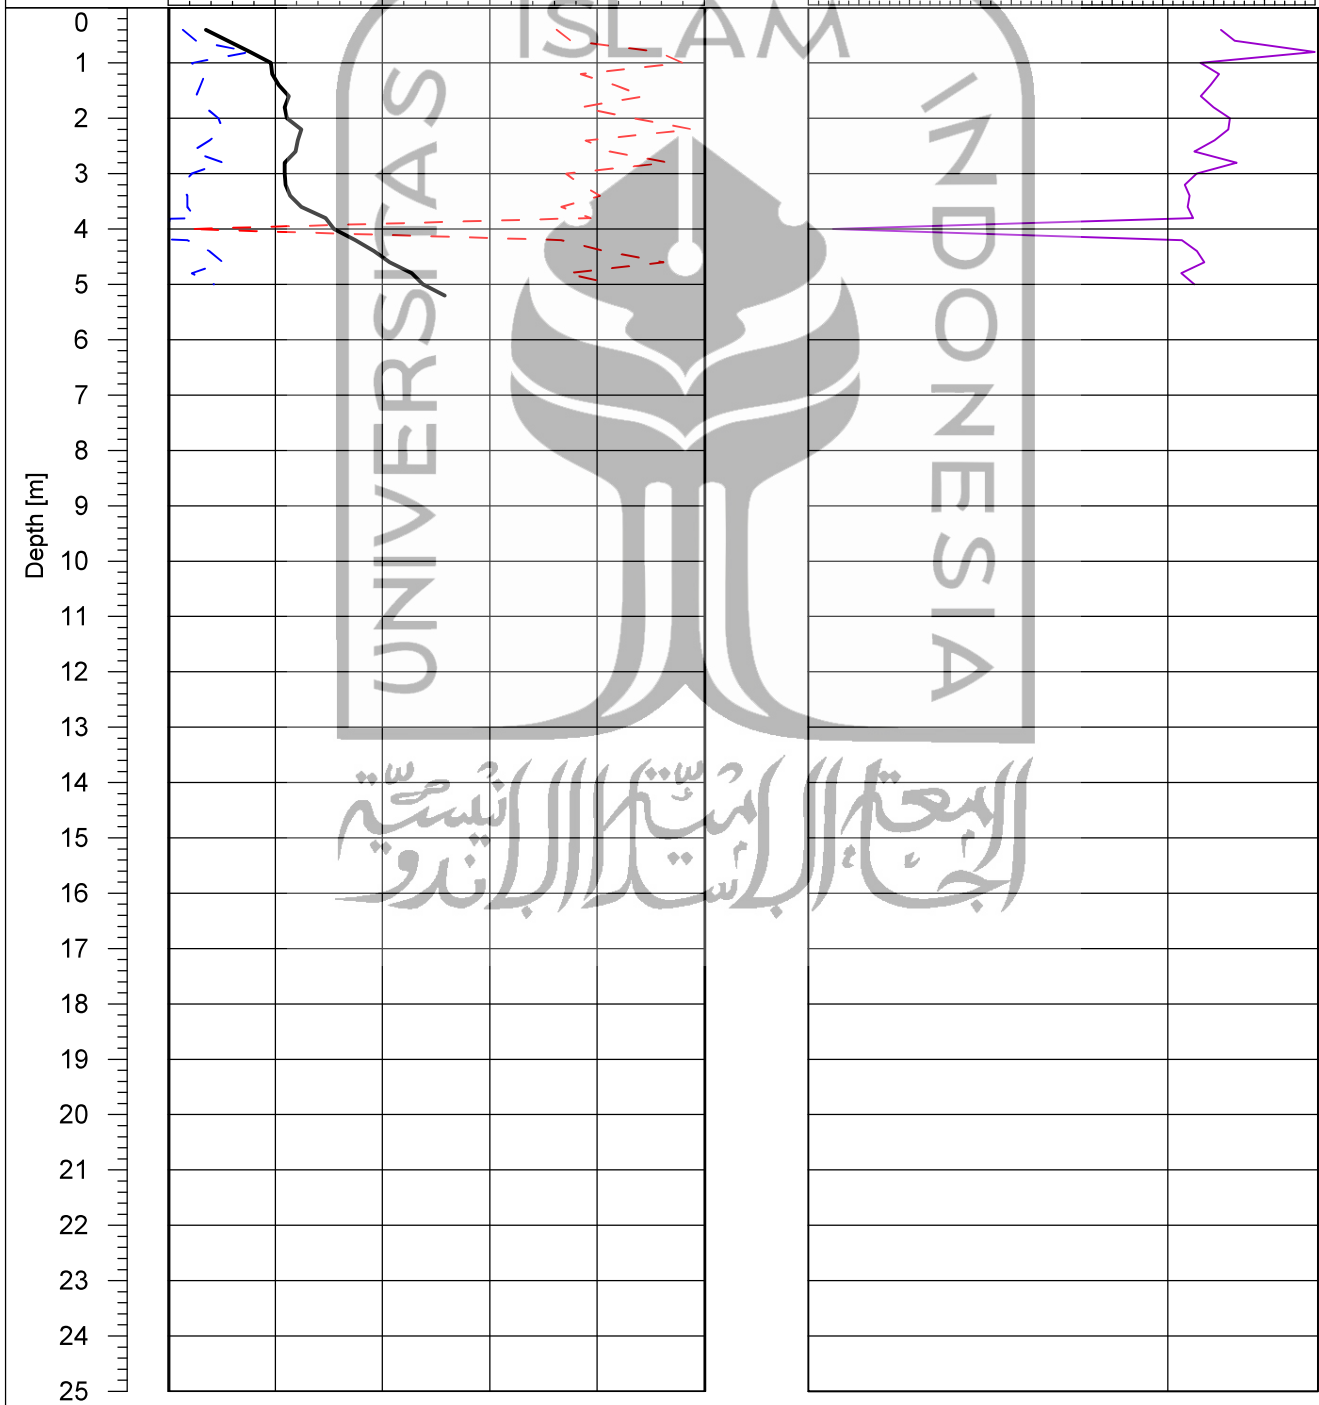
CPT - 11

CONE PENETRATION TEST ASTM D3441

Location : Desa Palihan Kec. Temon - Kulonprogo
