Lampiran 12 Kurva/Grafik Pengujian Kuat Lentur Terkoreksi

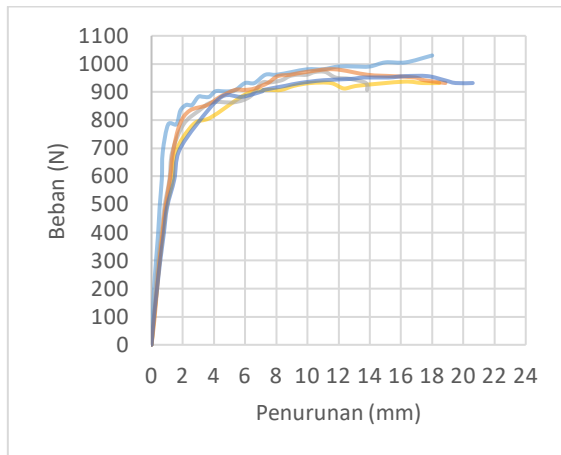
Grafik 12.1 Hasil Pengujian Kuat Lentur Baut 8mm Terkoreksi

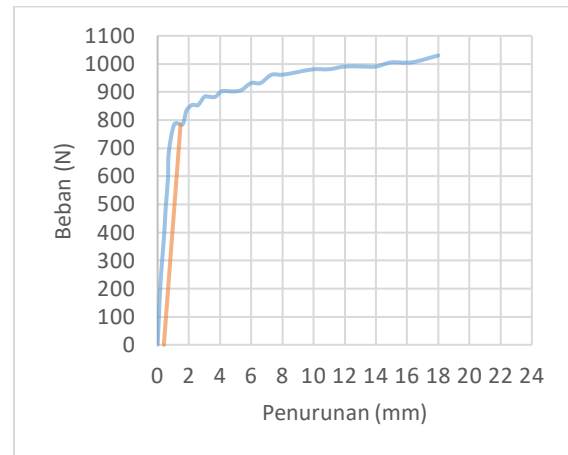
Grafik 12.2 Hasil Pengujian Kuat Lentur Baut KL-8mm-1 Terkoreksi

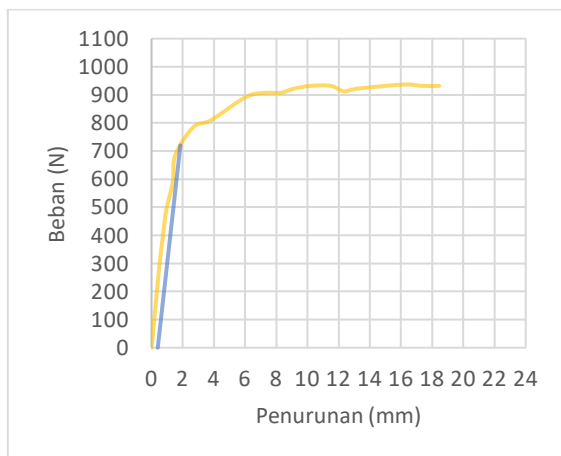
Grafik 12.3 Hasil Pengujian Kuat Lentur Baut KL-8mm-2 Terkoreksi

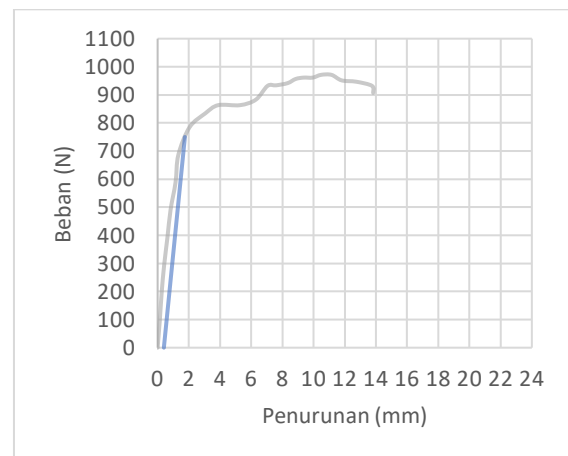
Grafik 12.4 Hasil Pengujian Kuat Lentur Baut KL-8mm-3 Terkoreksi

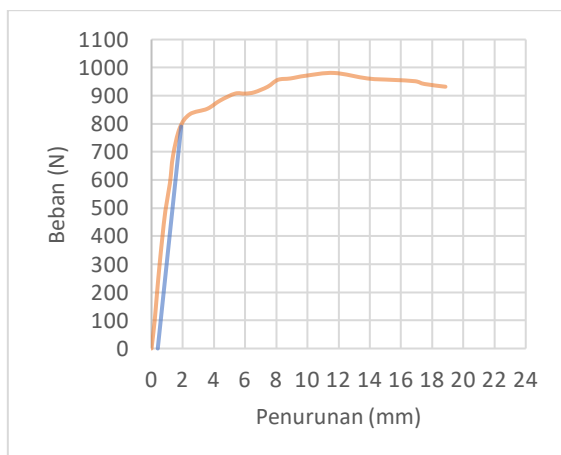
Grafik 12.5 Hasil Pengujian Kuat Lentur Baut KL-8mm-4 Terkoreksi

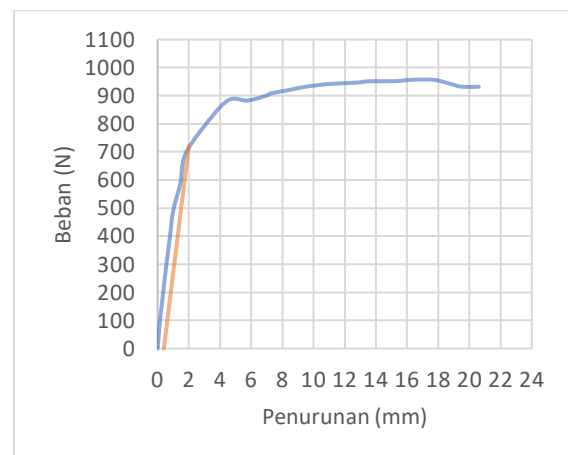
Grafik 12.6 Hasil Pengujian Kuat Lentur Baut KL-8mm-5 Terkoreksi

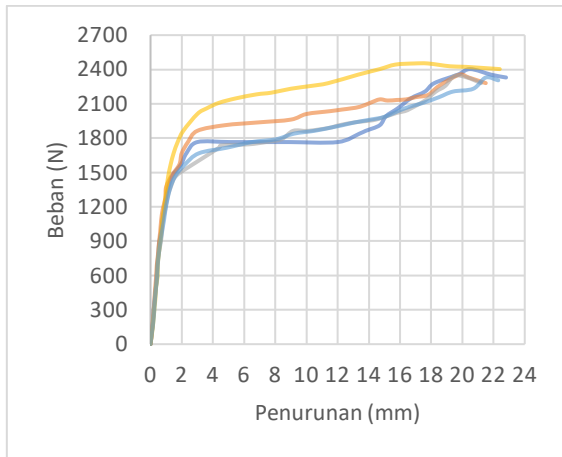
Grafik 12.7 Hasil Pengujian Kuat Lentur Baut 10mm Terkoreksi

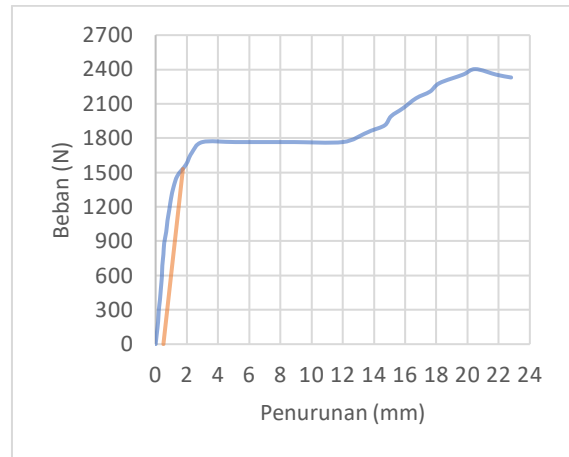
Grafik 12.8 Hasil Pengujian Kuat Lentur Baut KL-10mm-1 Terkoreksi

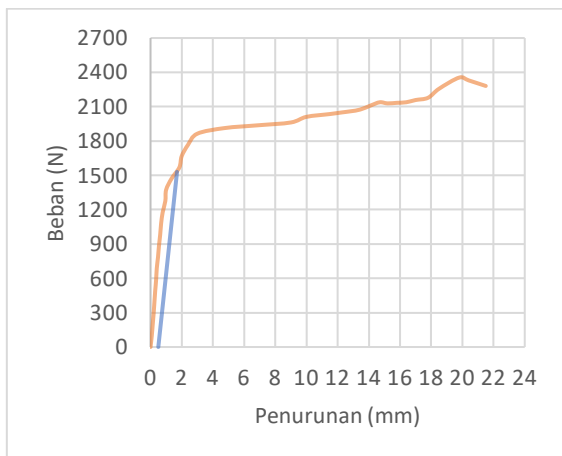
Grafik 12.9 Hasil Pengujian Kuat Lentur Baut KL-10mm-2 Terkoreksi

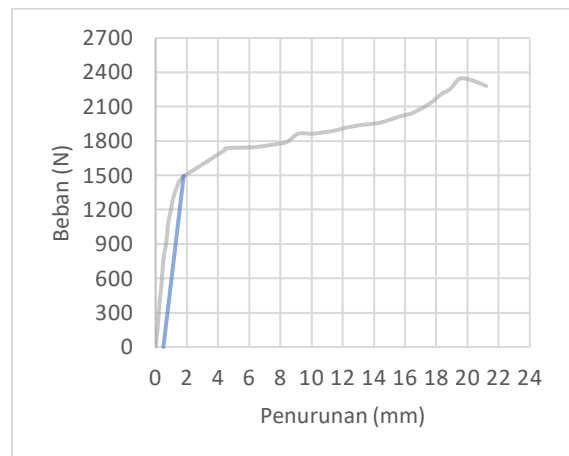
Grafik 12.10 Hasil Pengujian Kuat Lentur Baut KL-10mm-3 Terkoreksi

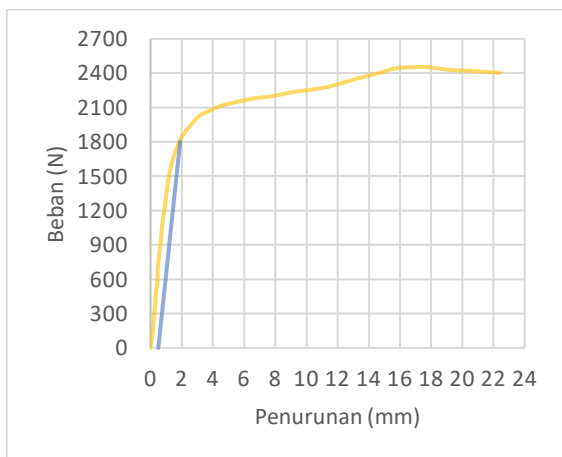
Grafik 12.11 Hasil Pengujian Kuat Lentur Baut KL-10mm-4 Terkoreksi

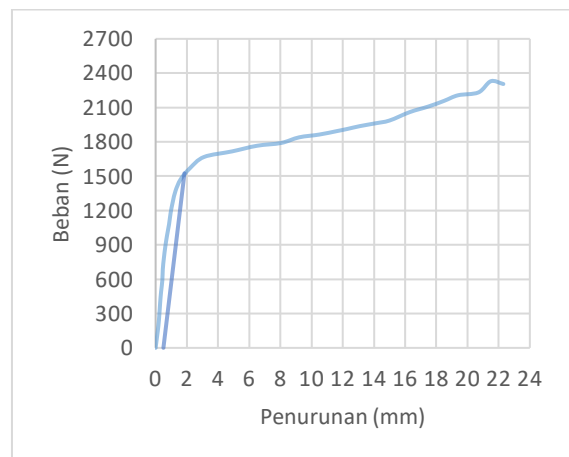
Grafik 12.12 Hasil Pengujian Kuat Lentur Baut KL-10mm-5 Terkoreksi

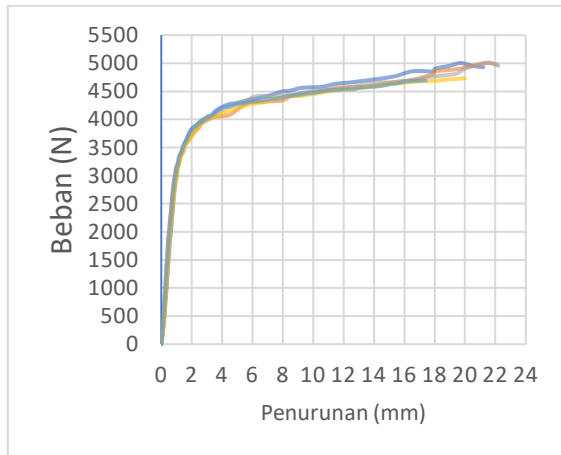
**Grafik 12.13 Hasil Pengujian Kuat Lentur
Baut 12mm Terkoreksi**

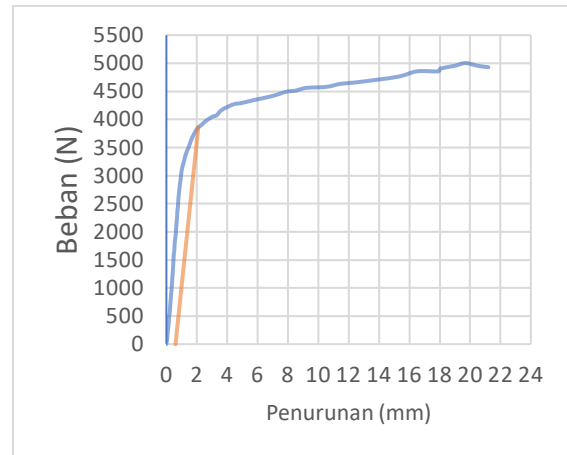
**Grafik 12.14 Hasil Pengujian Kuat Lentur
Baut KL-12mm-1 Terkoreksi**

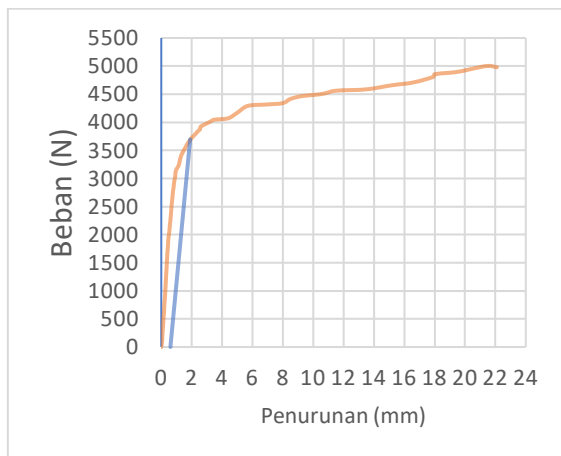
**Grafik 12.15 Hasil Pengujian Kuat Lentur
Baut KL-12mm-2 Terkoreksi**

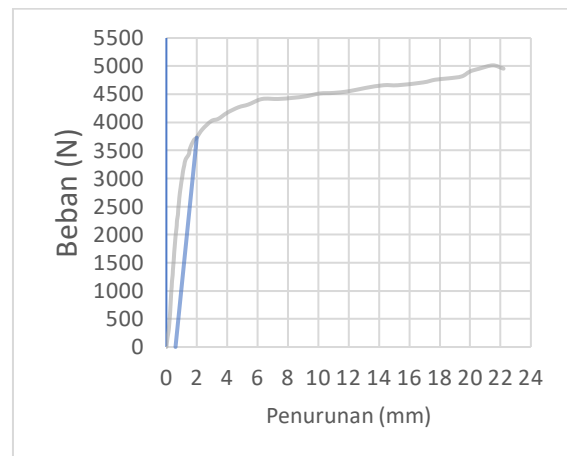
**Grafik 12.16 Hasil Pengujian Kuat Lentur
Baut KL-12mm-3 Terkoreksi**

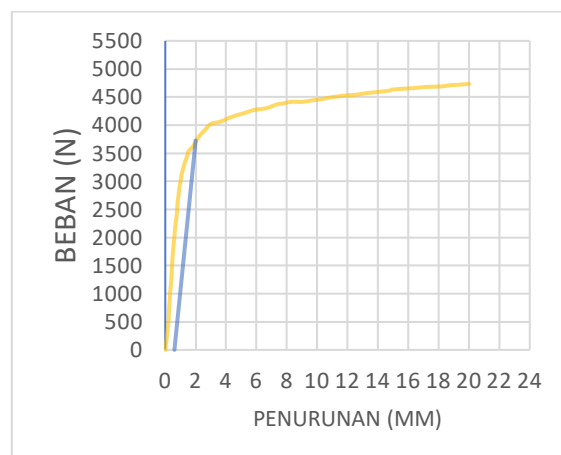
**Grafik 12.17 Hasil Pengujian Kuat Lentur
Baut KL-12mm-4 Terkoreksi**

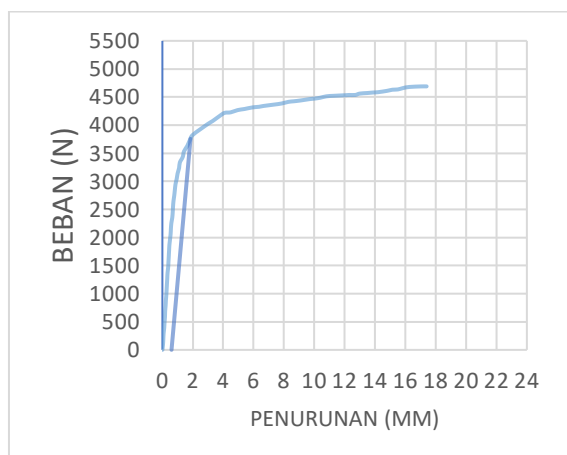
**Grafik 12.18 Hasil Pengujian Kuat Lentur
Baut KL-12mm-5 Terkoreksi**
